| Applicant: Dept.of Planning and Natural Resources - STJ | Damage Inventory # 234205 & 234213 | Category E |
| Damage Facility: JMU4F02 - Bldgs and Equip,Sprauve Library and M | | |

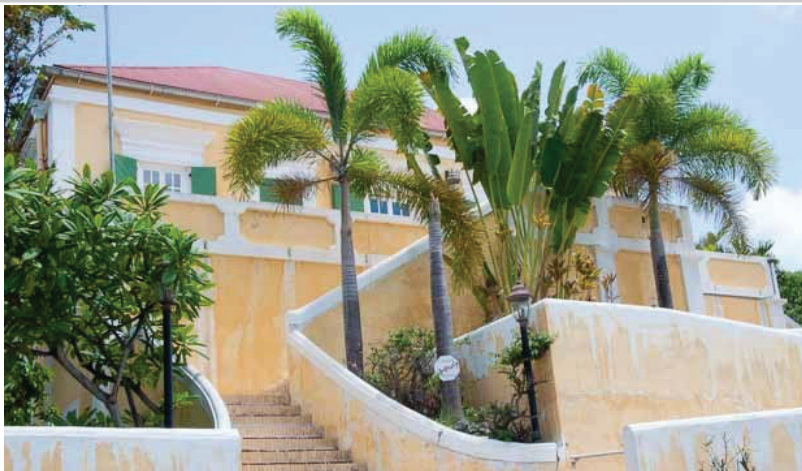
| Damage Description: | Photo# 1 |

| Pre-Disaster- Overall West Exterior Wall Elevation | |

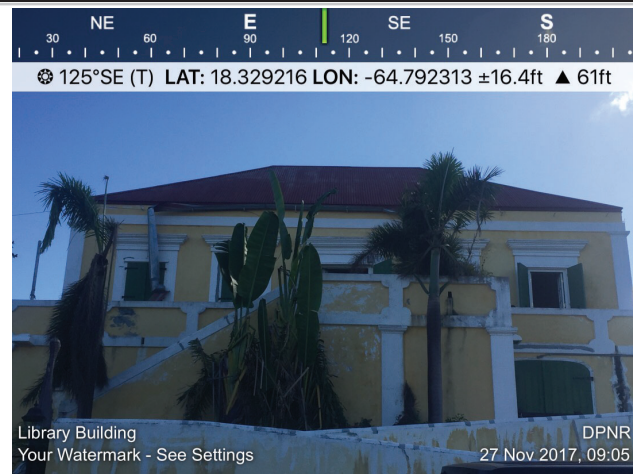
| Damage Description | Photo# 2 |

| West Exterior Wall Elevation (11-27-2017) | |

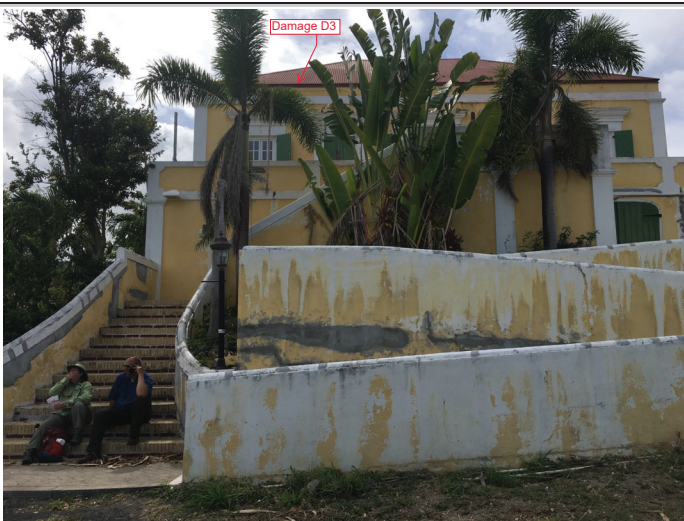
| Damage Description: | Photo# 3 |

| D3,D19&D20- West Exterior Wall elevation (06-06-2018) | |

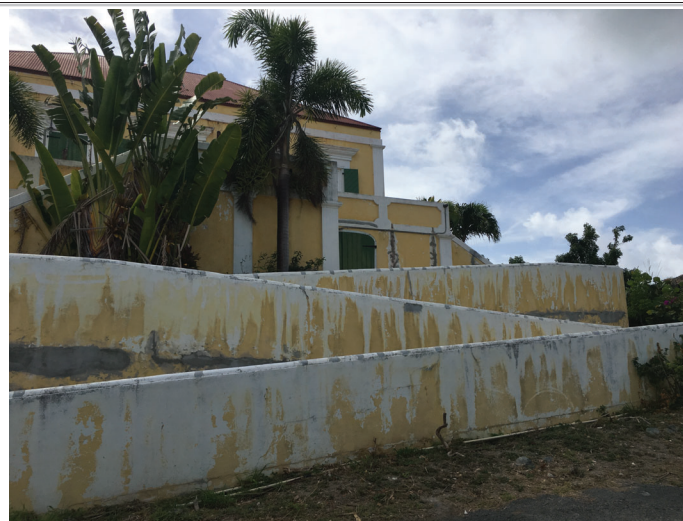
| Damage Description | Photo# 4 |

| D20,D21&D22- West Exterior Wall Elevation (06-06-2018) | |

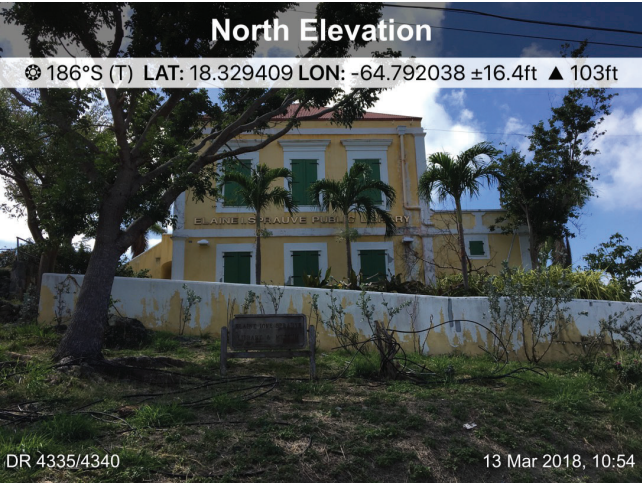
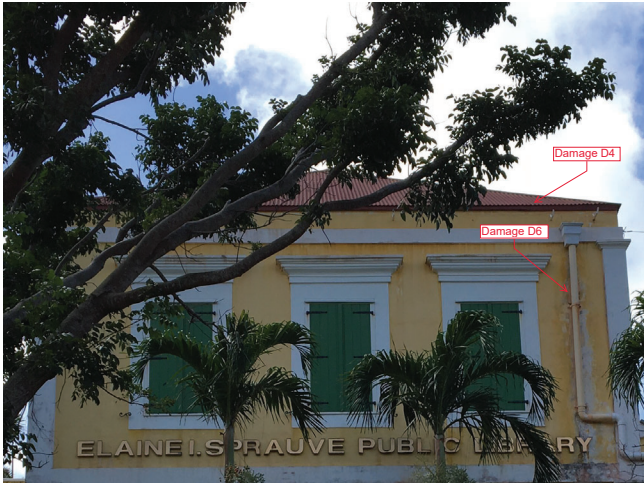
| <div> <div>Photo#</div> <div>5</div> </div> <div>D19&D20- North Exterior Wall Elevation (03-13-2018)</div> | | <div> <div>Damage Description</div> <div>Photo#</div> <div>6</div> </div> <div>D4&D6- North Exterior Wall Elevation (03-13-2018) Cropped</div> | | | |

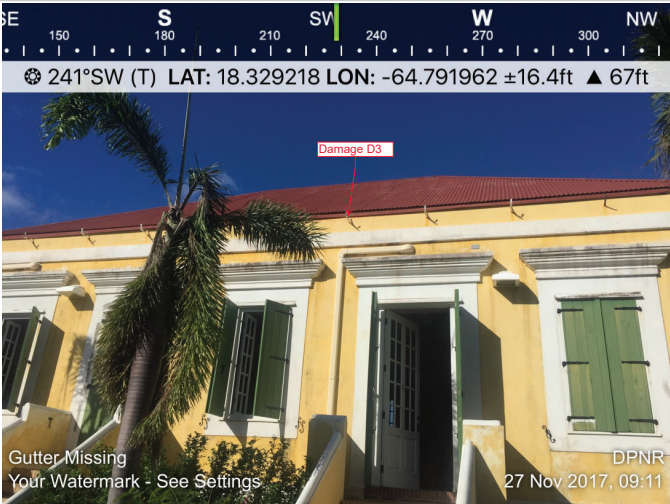
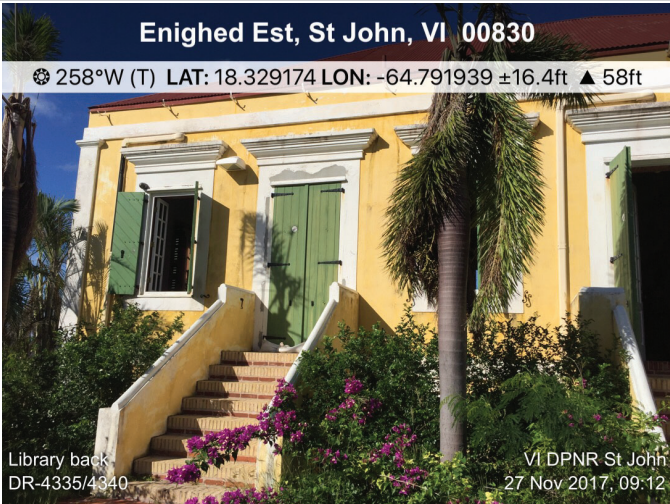
| <div> <div>Damage Description:</div> <div>Photo#</div> <div>7</div> </div> <div>D3,D19&D23- East Exterior Wall Elevation (11-27-2017)</div> | | <div> <div>Damage Description</div> <div>Photo#</div> <div>8</div> </div> <div>D19&D23- East Exterior Wall Elevation (11-27-2017)</div> | | | |

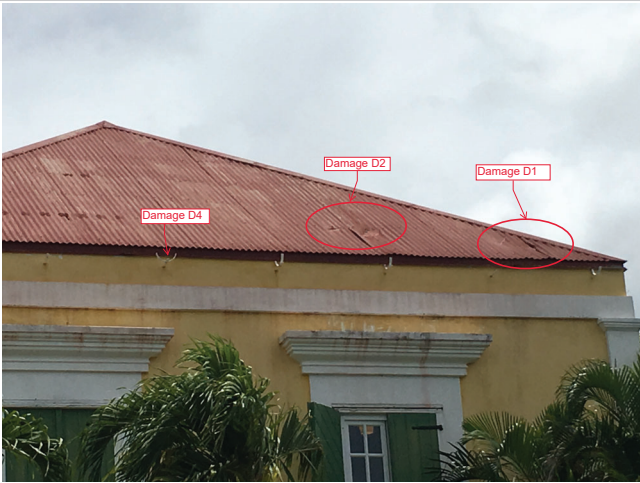
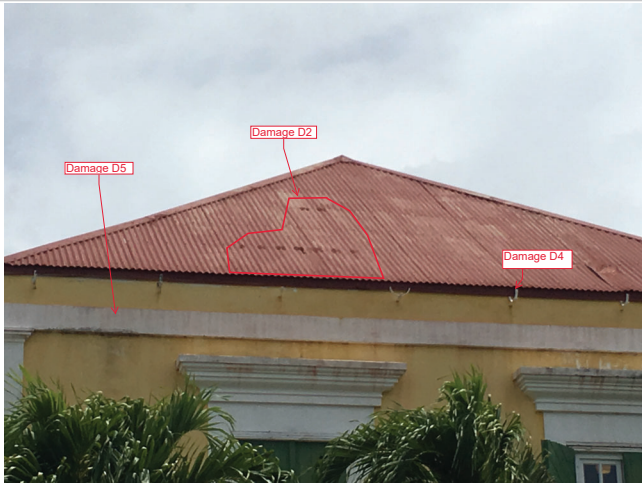
| | | Photo# 9 | | Photo# 10 | |

| D1,D2&D4- South Exterior Wall Elevation (06-06-2018) | | D2,D4&D5- South Exterior Wall Elevation (06-06-2018) | | | |

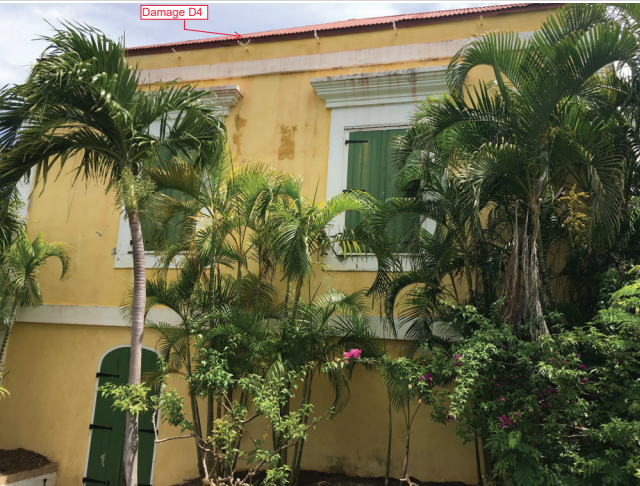
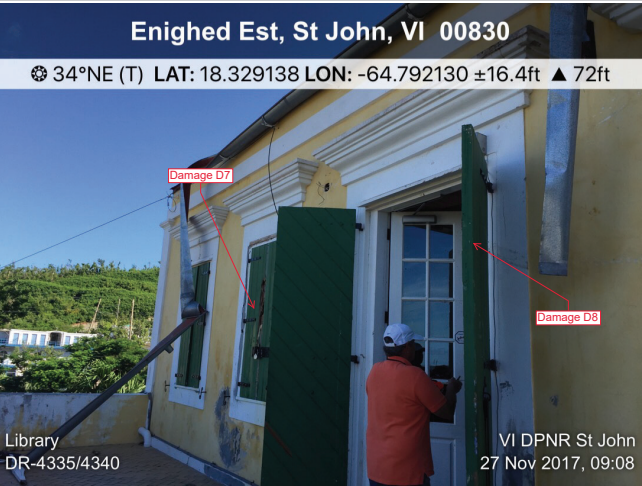
| D4&D19- South Exterior Wall Elevation (07-08-2018) | | D7,D8&D13- West Exterior Window #1 & Door #1 Shutters (11-27-2017) | | | |

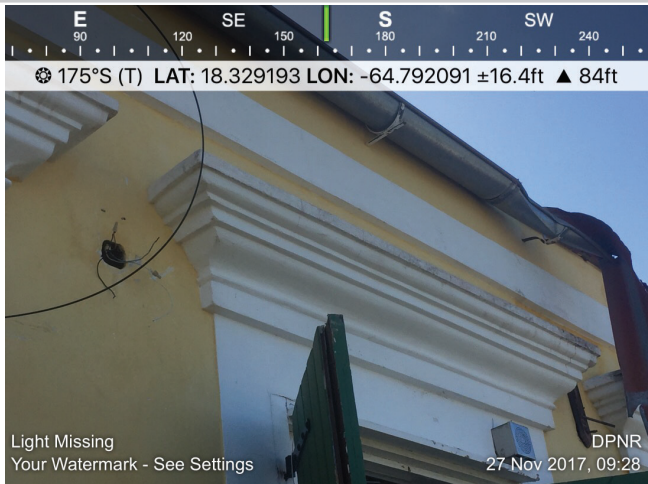
| D9- West Exterior Door #1 (11-27-2017) | |

| D9- West Exterior Door #1 (06-06-2018) | |

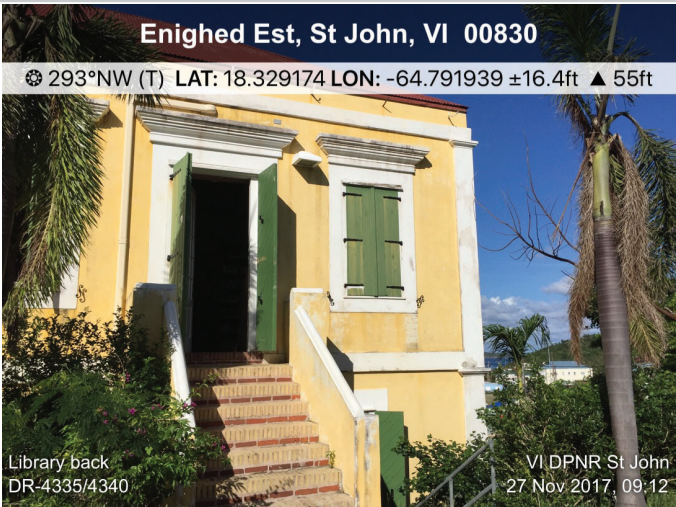
| Damage Description: | Photo# 19 |

| D10- East Exterior Door #2 Shutters (11-27-2017) | |

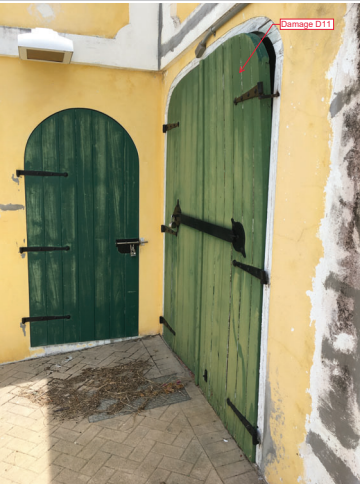
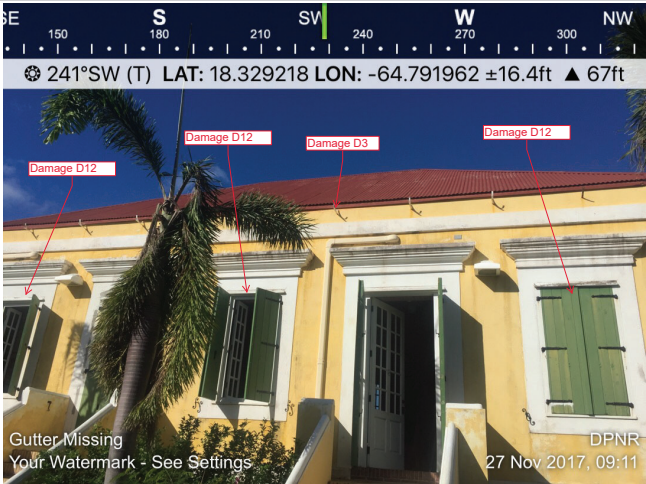
| D11- Lower West Exterior Courtyard Door #4 Shutters (06-06-2018) | | | | D12- South Exterior Window #4,5,&7 Shutters (11-27-2017) | |

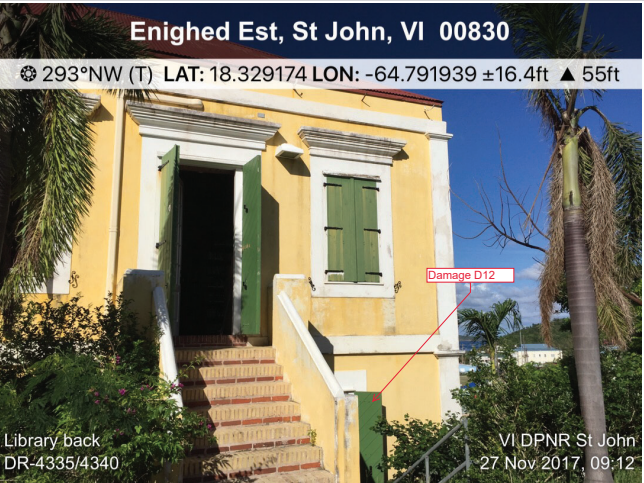
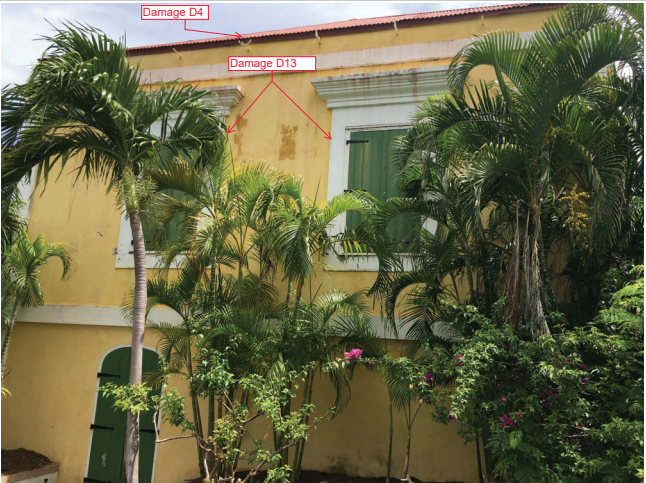
| D12- South Exterior Window #8 Shutters (07-08-2018) | | | | D13- South Exterior Window #9 & 10 Shutters (11-27-2017) | |

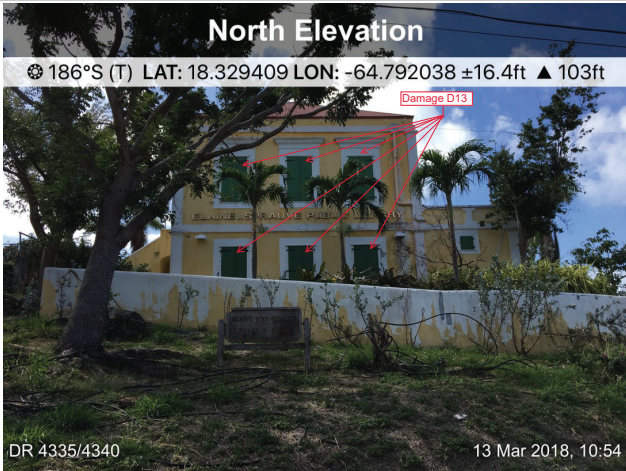
| D13- North Exterior Window #11,12,13,14,15 &16 Shutters (03-13-2018) | | | | |

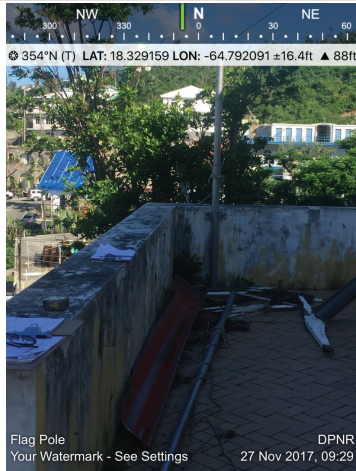
| D14- West Exterior Veranda Flag Pole (11-27-2017) | | | | |

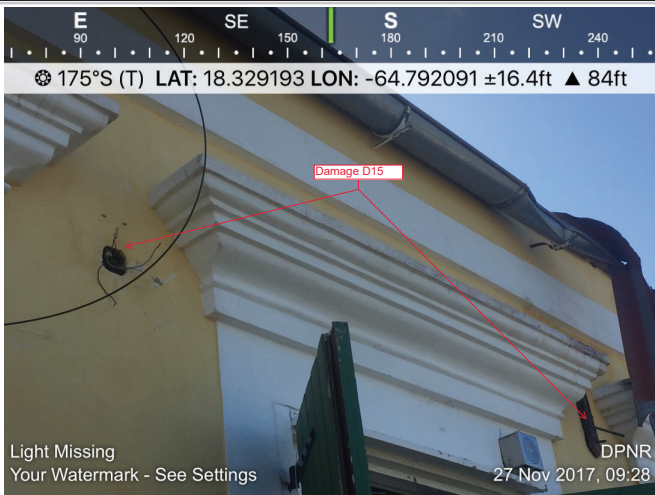
| D15- West Exterior Door Wall Light Sconces Fixtures #1 & 2 (06-06-2018) | | | | |

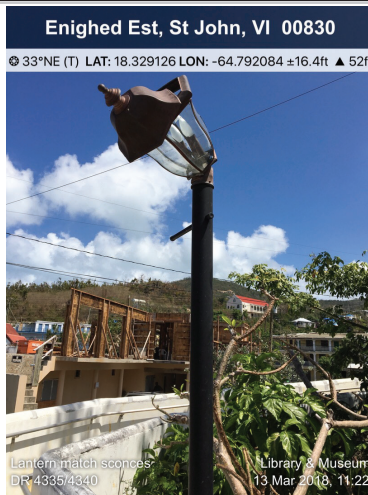
| D16- West Exterior Veranda Lamp Post Light Fixture (03-13-2018) | | | | |

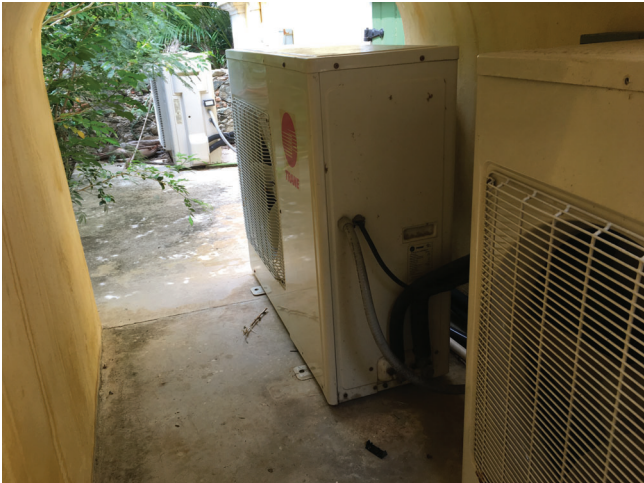
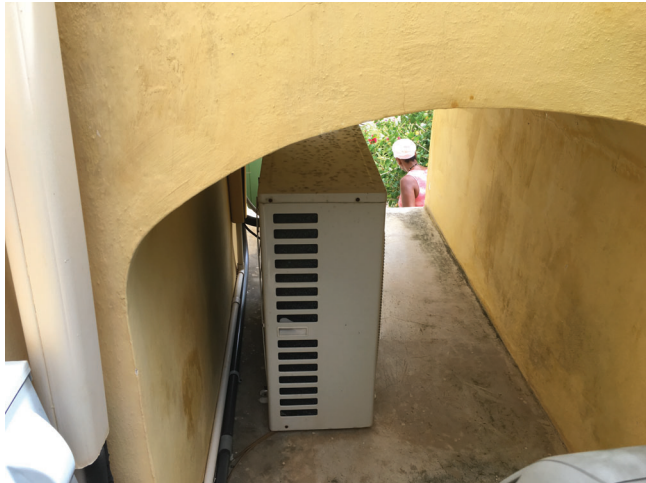
| D18- S-East Exterior Air Conditioning Unit #1,2&3 Physical Layout (06-06-2018) | | D18- N-East Exterior Air Conditioning Unit #4 Physical Layout (06-06-2018) | | | |

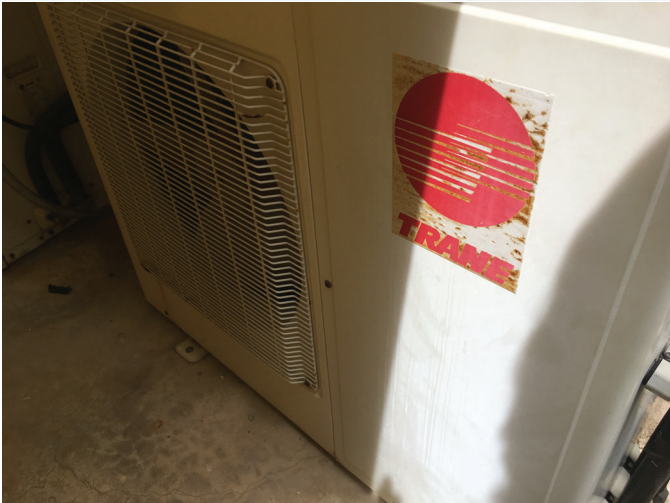
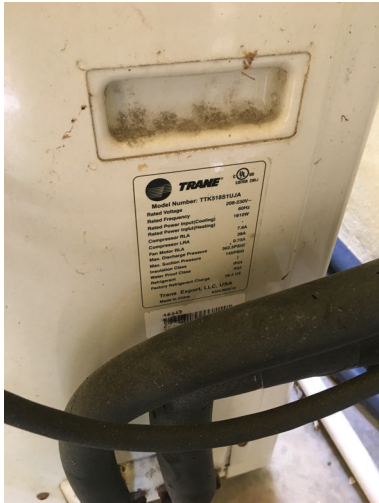
| D18- S-East Exterior Air Conditioning Manufacturer (06-06-2018) | | | | D18- S-East Exterior Air Conditioning Model Information (06-06-2018) | |

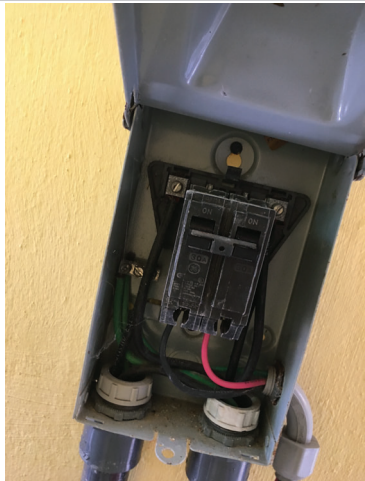
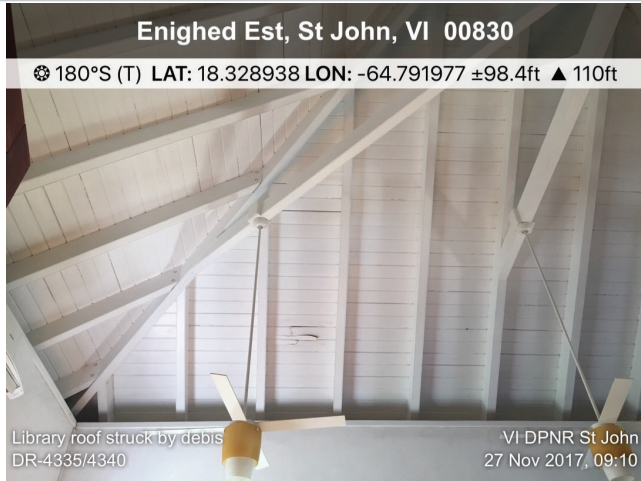
| | | Photo# 37 | | Photo# 38 | |

| D18- S-East Exterior Air Conditioning Disconnection Switch (06-06-2018) | | D24- Tongue & Grooved Section of Library First Floor Ceiling (SE corner)(11-27-2017) | | | |

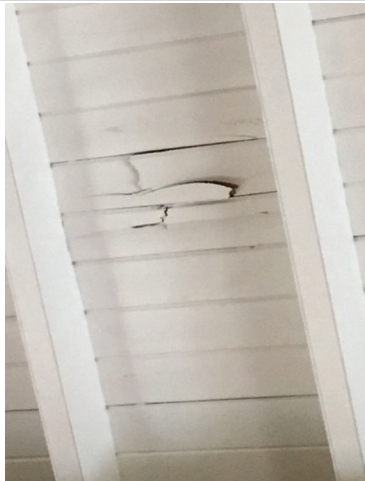
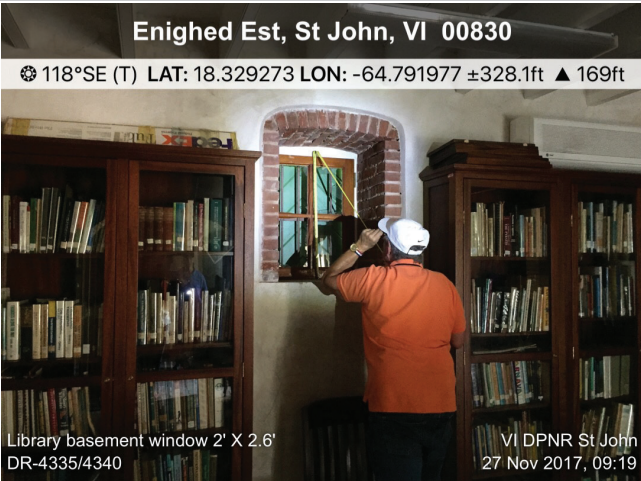
| D24- Tongue & Grooved Section of Library First Floor Ceiling (SE corner) (11-27-2017) | | D25- Water Leakage and Extensively Discolored Coating Damage of the Basement Masonry Wall (11-27-2017) | | | |

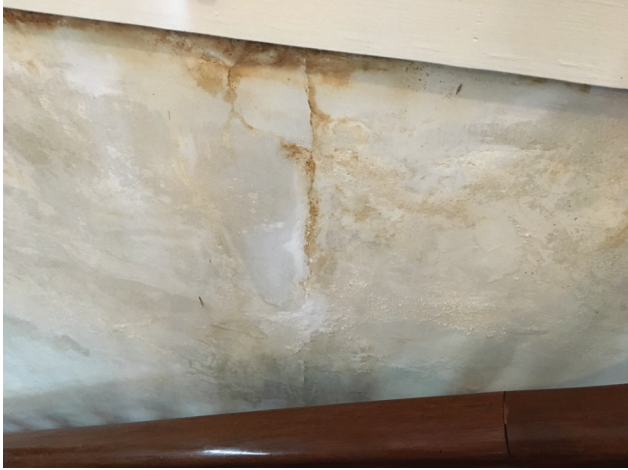
| D25- Water Leakage and Extensively Discolored Coating Damage of the Basement Masonry Wall (11-27-2017) | | | | |

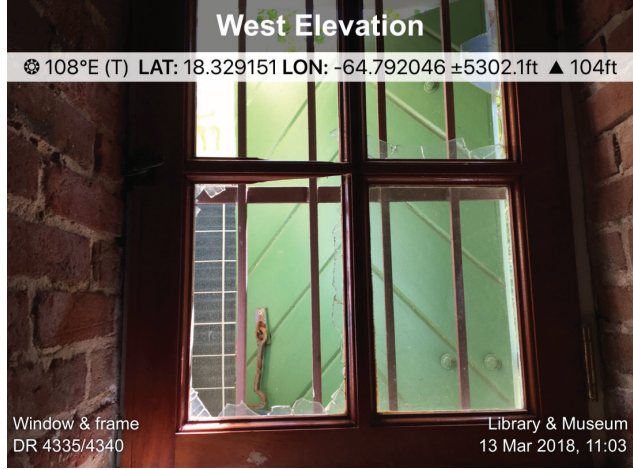
| D26- West Basement Wall Window Frame and Glass Panes Broken (03-13-2018) | | | | |

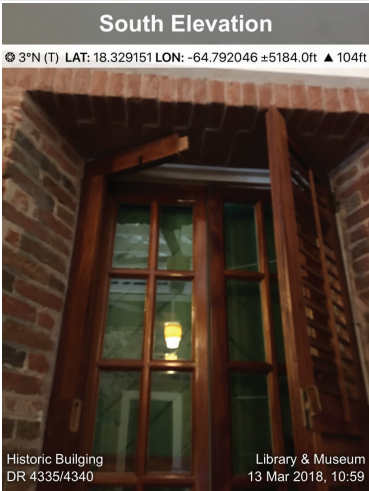
| D27- South Basement Wall Wooden Interior Louvered Window Shutters (03-13-2018) | | | | |

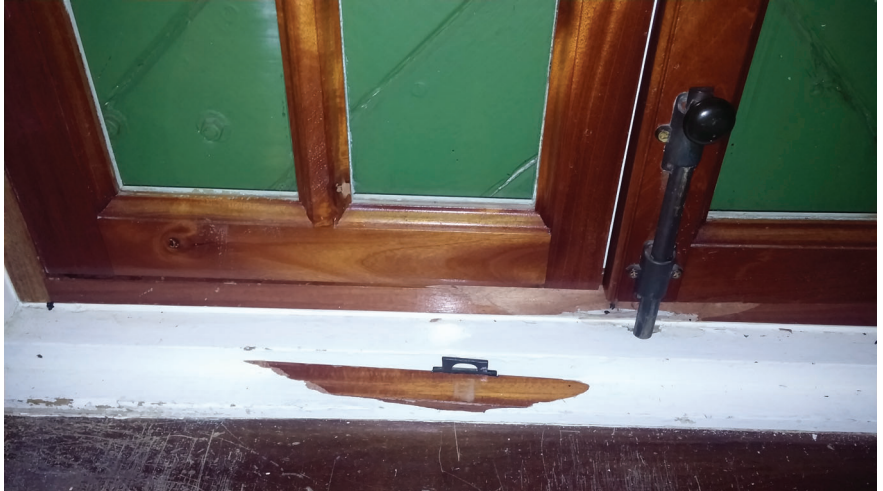
| D28- South Exterior Wall Window Damaged Window Latch at First Floor (04-10-2018) | | | | |

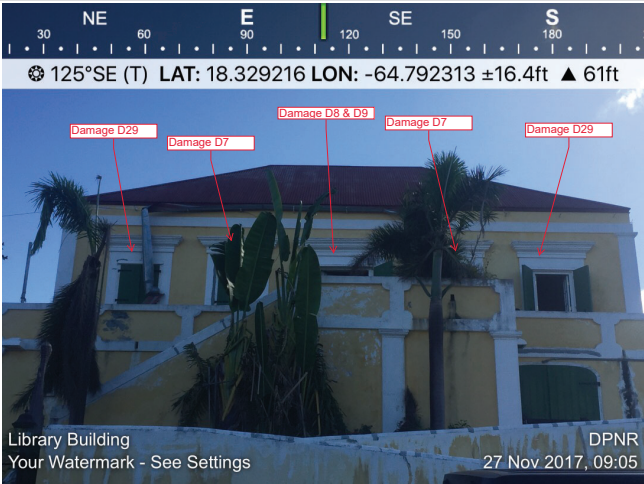
| Damage Description: | Photo# 45 |

| D29- North Exterior Window #11,12,13,14,15 &16 Shutters (03-13-2018) | |

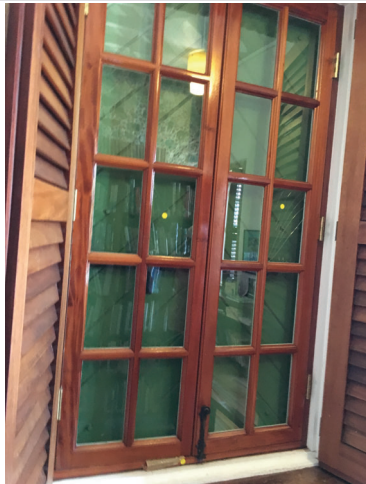
| Damage Description | Photo# 46 |

| D30- South Exterior Wall Door Broken Glass Panes on the First Floor (06-06-2018) | |

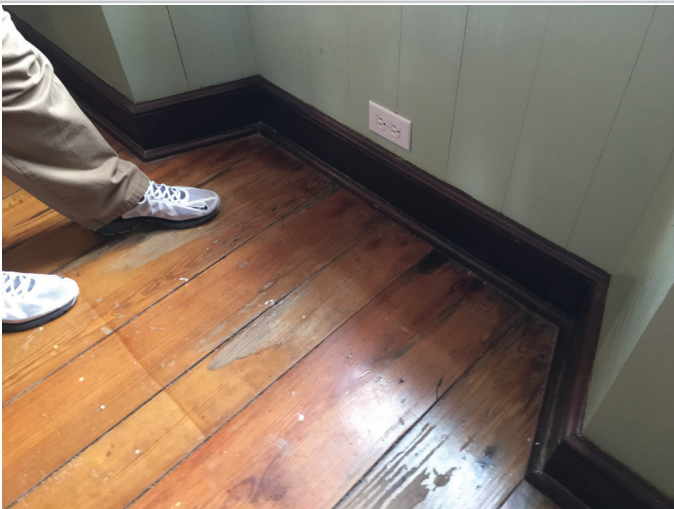
| Damage Description: | Photo# 47 |

| D31- East Exterior Wall Water Damaged Hardwood Flooring at Broken First Floor Window (06-06-2018) | |

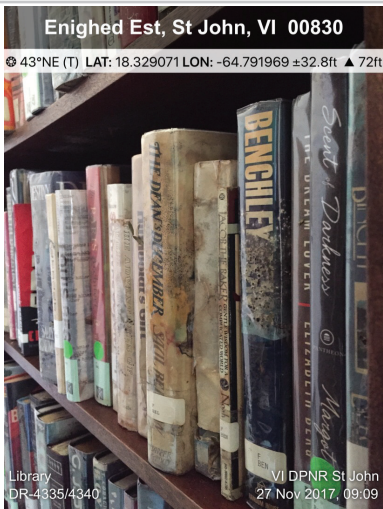
| Damage Description | Photo# 48 |

| D32- Contents: Adult Fiction Hardback Novels Water Damaged - 10 shelves that hold approximately 25 books each (11-27-2017) | |

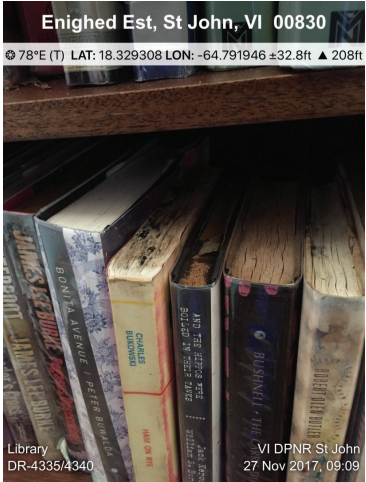
| D32- Contents: Adult Fiction Hardback Novels Water Damaged - 10 shelves that hold approximately 25 books each (11-27-2017) | | | |
