## Contractor Scope & Bid Sheet

# Repairs to Elaine Ione Sprauve Public Library Cruz Bay, St. John

Prepared by DPW/CIP Office

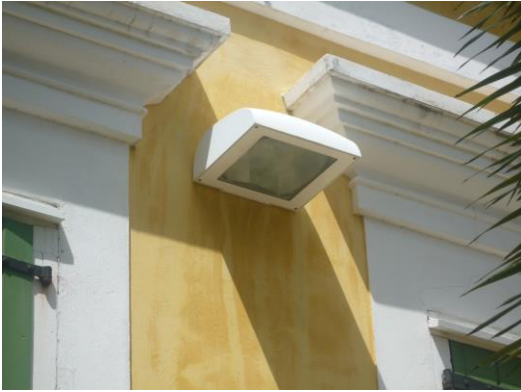
**Item No. 01** metal door to be replaced

| Item No. | Item Description | Quantity | Unit Cost<br>(Material & Labor) | Total Cost<br>(Material & Labor) |
|---|---|---|---|---|
| 01. | <b><u>East side of facility...</u></b> Install two additional security light fixture to match existing security lighting. Proposed light fixtures shall be installed at bond beam level at each corner of the building. All conduits and wiring shall be discretely installed not to disturb the historic aesthetic integrity of the facility. Proposed wiring shall be connected to the existing security lighting and shall work in unity. Amperage shall be verified for proper voltage. | Two (2)<br>security light<br>fixture | \$ _____ | \$ _____ |

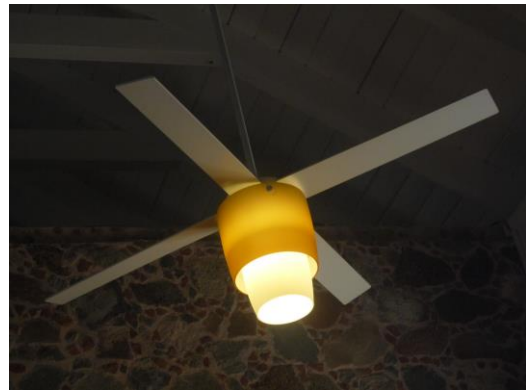
**Item No. 02** light/fan to be repaired

| Item No. | Item Description | Quantity | Unit Cost<br>(Material & Labor) | Total Cost<br>(Material & Labor) |
|---|---|---|---|---|
| 02. | <b><u>Second level over staircase...</u></b> Repair existing light/fan fixture ensuring proper operation of the light. The fan portion of the fixture seems to be decorative and repairs to its operation is not necessary. | One (1)<br>light/fan | \$ <u>lump</u> | \$ _____ |

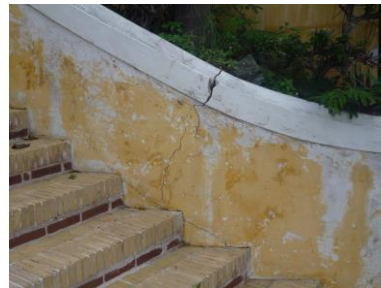
**Item No. 04** Cracked stair masonry railing

| Item No. | Item Description | Quantity | Unit Cost<br>(Material & Labor) | Total Cost<br>(Material & Labor) |
|---|---|---|---|---|
| 04. | <b><u>Masonry Cracked Wall...</u></b> Repair approximately 32 linear feet of masonry cracked wall by chipping and plaster damaged wall with properly mixed cement mortar. Cracked wall is located at structure's south-east corner. | 32 lin. ft. | \$ _____ | \$ _____ |

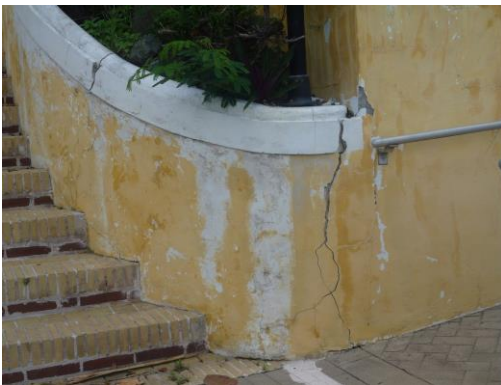
**Item No. 06** Cracked stair masonry railing

| Item No. | Item Description | Quantity | Unit Cost<br>(Material & Labor) | Total Cost<br>(Material & Labor) |
|---|---|---|---|---|
| 06. | <b><u>Main South Entrance to Facility...</u></b> Chip and plaster (with properly mixed cement mortar) approximately ten (10) linear feet of structure's main entrance staircase masonry wall/railing | 10 lin. ft. | \$ _____ | \$ _____ |

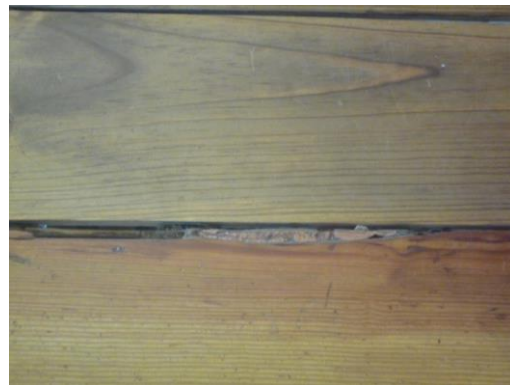
**Item No. 07** Planters destroyed by tree roots

| Item No. | Item Description | Quantity | Unit Cost<br>(Material & Labor) | Total Cost<br>(Material & Labor) |
|---|---|---|---|---|
| 07. | <b><u>Second Floor...</u></b> Using recommended/approved wood filler, repair approximately twelve (12) linear feet of broken flooring. The hole is located in front of circulation desk. | 12 lin. ft. | \$ _____ | \$ _____ |

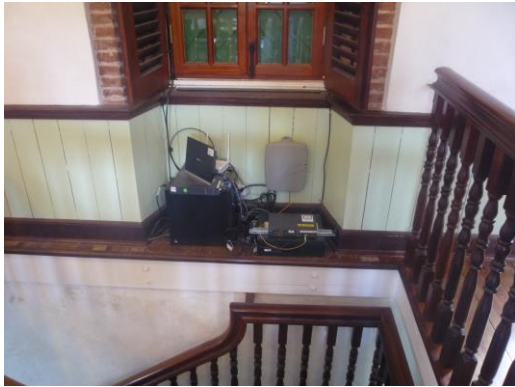
**Item No. 08** Computer/Internet Equipment

| Item No. | Item Description | Quantity | Unit Cost<br>(Material & Labor) | Total Cost<br>(Material & Labor) |
|---|---|---|---|---|
| 08. | <b><u>Computer/Internet Equipment Cabinet...</u></b> Fabricate a 4'-0" x 2'-6" x 1'-4" treated wooden cabinet to house existing computer/internet equipment. Anticipate using wood to match surrounding area. Cabinet shall be varnish painted to match existing surrounding. Cabinet shall be placed below window where existing equipment are presently located. | One (1)<br>cabinet | \$ _____ | \$ _____ |

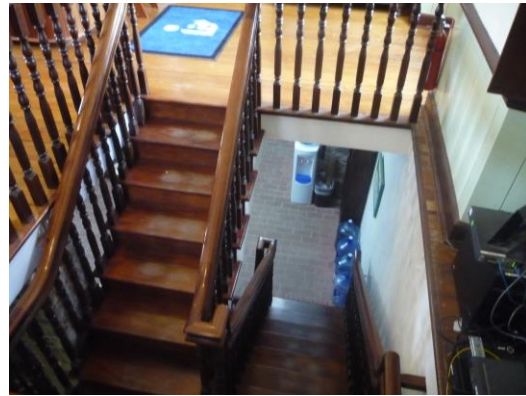
**Item No. 09** Repairs around doors and window sill

| Item No. | Item Description | Quantity | Unit Cost<br>(Material & Labor) | Total Cost<br>(Material & Labor) |
|---|---|---|---|---|
| 09. | <b><u>Railing Stability...</u></b> Existing interior stair railing from first to second floor shall be stabilize to avoid existing rocking tendency. Method and approach shall be discussed with GVI representative prior to commencement of work. | lump | \$ _____ | \$ _____ |

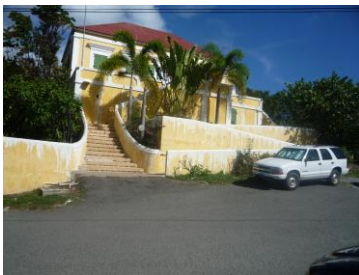
**Item No. 12** Southern ADA access

| 12. | <b><u>ADA Access to First Floor...</u></b> Refer to attached drawing for ADA access to facility's first floor. Door buzzer and access buzz-in from Control Desk shall be install. | lump | lump | \$ _____ |

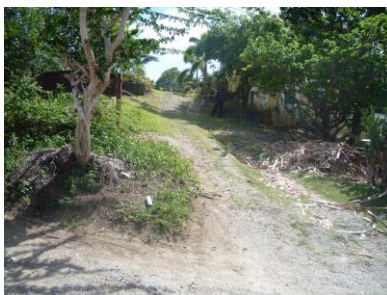
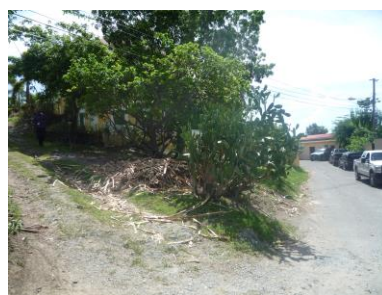
**Item No. 15 & 16** Existing unpaved driveway (North-west corner of facility)

| 15. | <b><u>Driveway construction...</u></b> Construct a 10'-0" wide x 80'-0" long x 6" thick driveway at the north side of existing facility. Compressive strength for the concrete shall be a minimum of 3,500 psi with No. 3 bars at 12" on center both ways. See attached drawing. | 22 yards | \$ _____ | \$ _____ |
| 16. | <b><u>ADA Parking Construction...</u></b> Construct a 12'-0" wide x 22'-0" long x 6" thick ADA parking at the north side of existing facility connecting to proposed driveway (as per item No. 16). Compressive strength for the concrete shall be a minimum of 3,500 psi with No. 3 bars at 12" on center both ways... In addition, include a 34'-0" long x 3'-0" high x 8" thick foundation walls/curb <u>and</u> 34'-0" long x 3'-0" wide x 1'-0" thick footing. See attached drawing. | 19 yards | \$ _____ | \$ _____ |
