MECHANICAL, ELECTRICAL, PLUMBING, AND FIRE PROTECTION  
SUMMARY REPORT  
UNITED STATES VIRGIN ISLANDS  
October 2015

Prepared by:  
InSynergy Engineering, Inc.

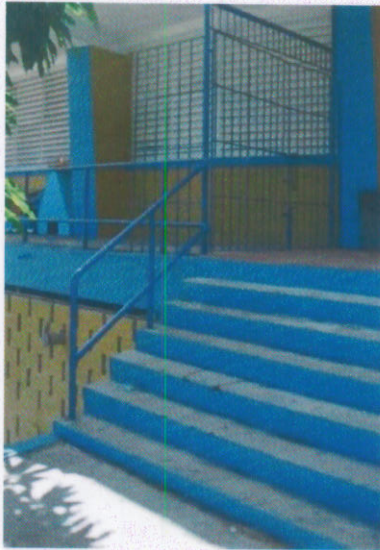
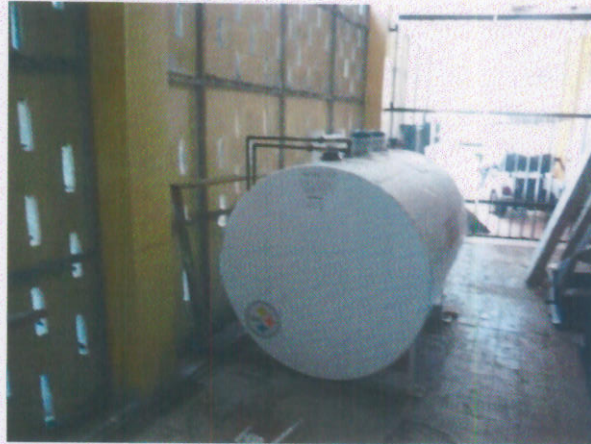
## 2. Building 05

FEMA emergency power generator engine exhausts were discharged adjacent to stair and walkway which posed health hazard to public. Fuel tank was not vented to outside the generator room. It was a fire safety due the accumulation of fuel vapor at the generator room.

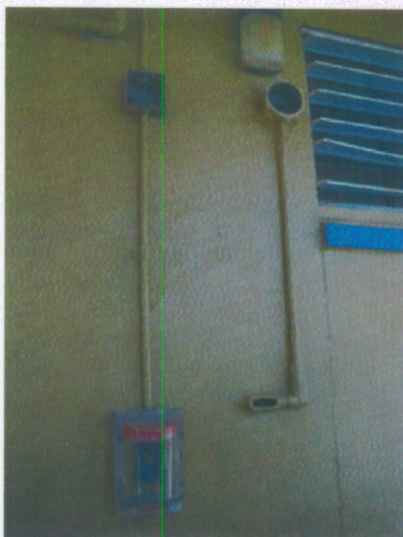
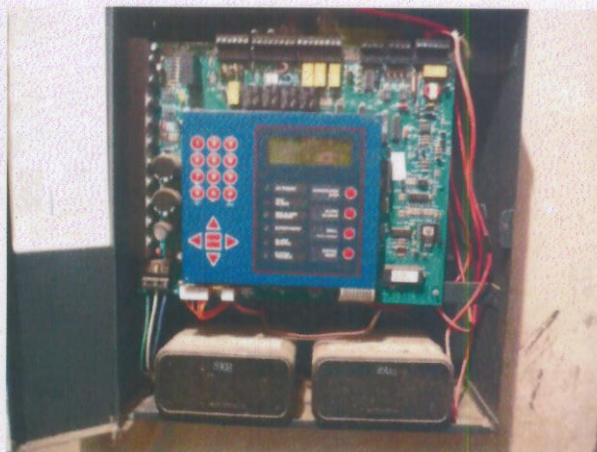
## 3. Fire alarm system

OIA Phase II survey found the fire alarm system was inoperable and incomplete. The fire alarm system remained inoperable and incomplete throughout the campus in OIA Phase III survey. This poses a safety hazard to the occupants. New fire alarm system should be provided throughout the campus and be upgradable for future voice communication.

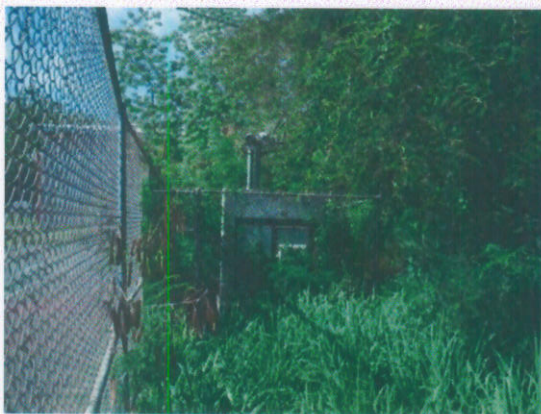
Two electrical services with pole mounted transformers and low lying weather heads. WAPA recommended to have these services relocated to provide ground pad mounted services.

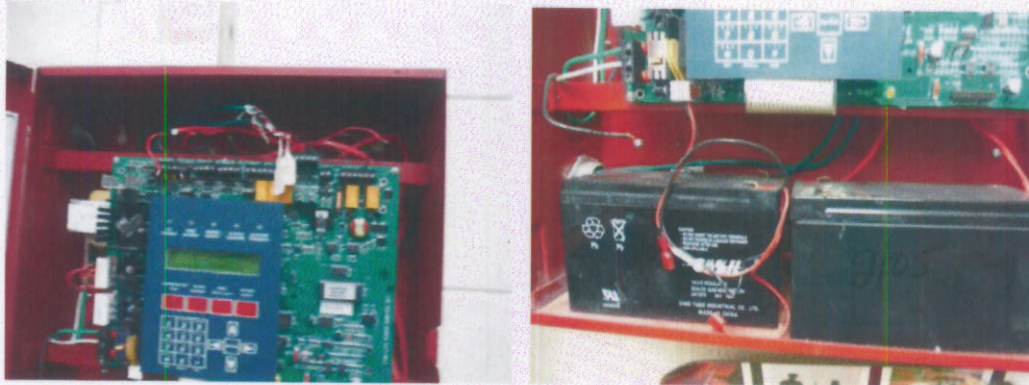
1. Fire alarm system

OIA Phase II survey found the fire alarm system was inoperable. During the OIA Phase III survey, the fire alarm panel power was off and batteries at the fire alarm panel were disconnected, posing a safety hazard to the occupants. The fire alarm system should be serviced and repaired to provide fire detection and notification throughout the campus and be upgradable for future voice communication.

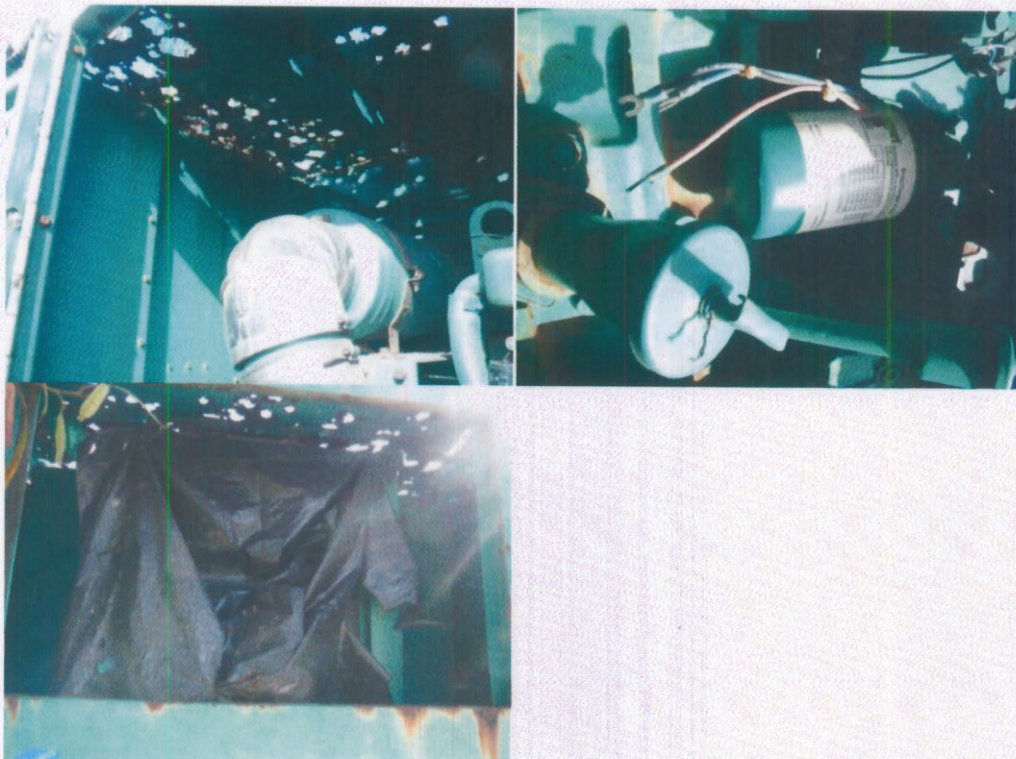
2. Electrical system

250kW standby generator housing (not FEMA generator) is badly corroded. Sensor wires are removed. Control panel covered by plastic. Generator needs repair and service or replacement.

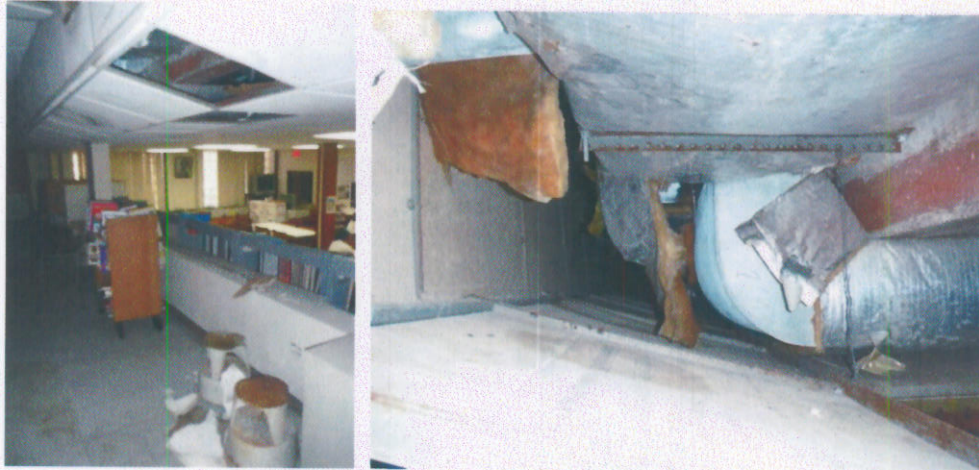
1. 08 – Administration and Library

Roof leaks and damage to the air conditioning ducting insulation caused condensation, moisture and mildew issues at the library. These issues posed health hazards to the occupants.

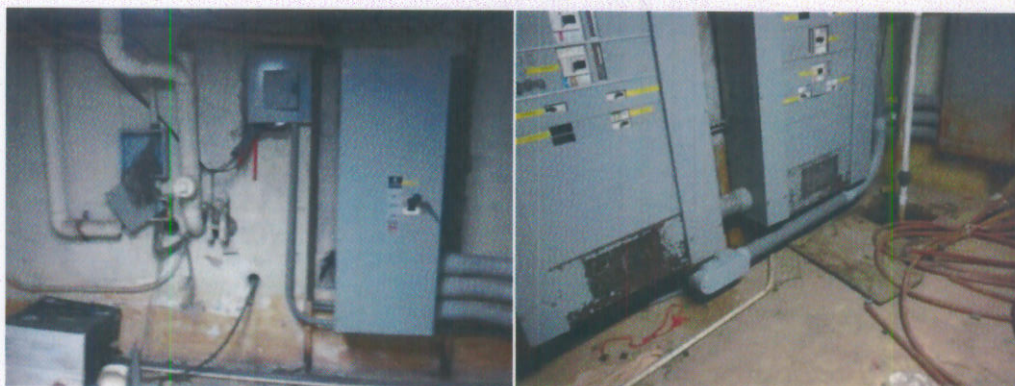
Main distribution panels are located at the main building (08 – Admin) basement. The electrical room in this building has an opening on perimeter wall causing flooding during heavy rain. Electrical panels have corroded covers and are vulnerable to flood damage. Main distribution panels and other electrical equipment are recommended to be relocated out of the basement.

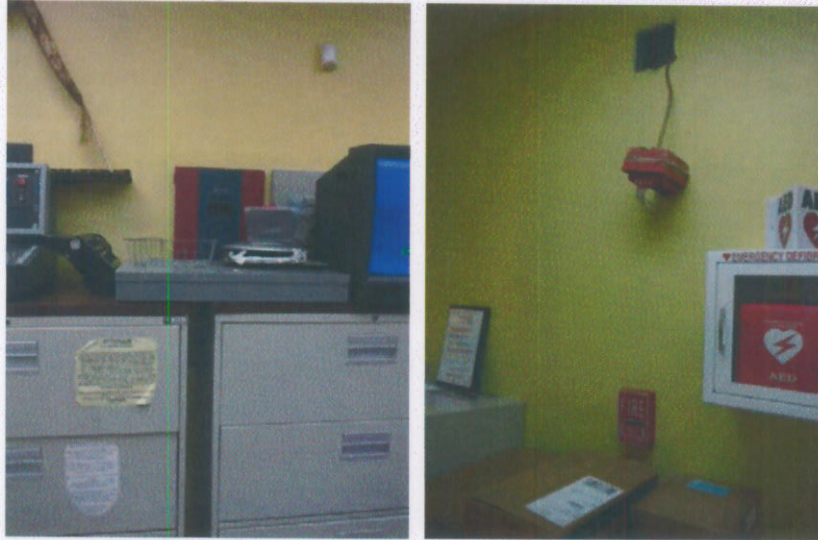
1. Fire alarm system

OIA Phase II survey found the fire alarm system required service and repair. During OIA Phase III, the fire alarm panel power was off. Fire alarm devices were not attached on the boxes. Both fire panel and manual pull station were obstructed. These are safety hazards. The fire alarm system should be serviced and repaired to provide fire detection and notification throughout the campus and be upgradable for future voice communication.

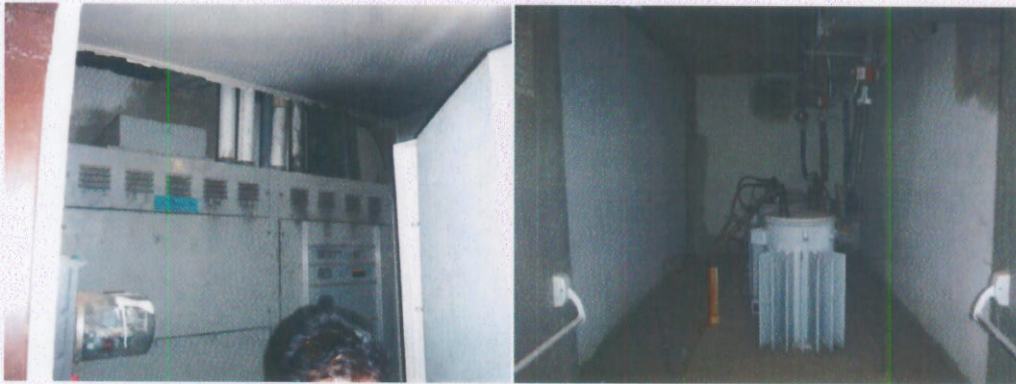
2. Electrical system

Transformers are located inside a room which has openings in the wall directly adjacent to the main electrical room. Main distribution panel has burn marks.

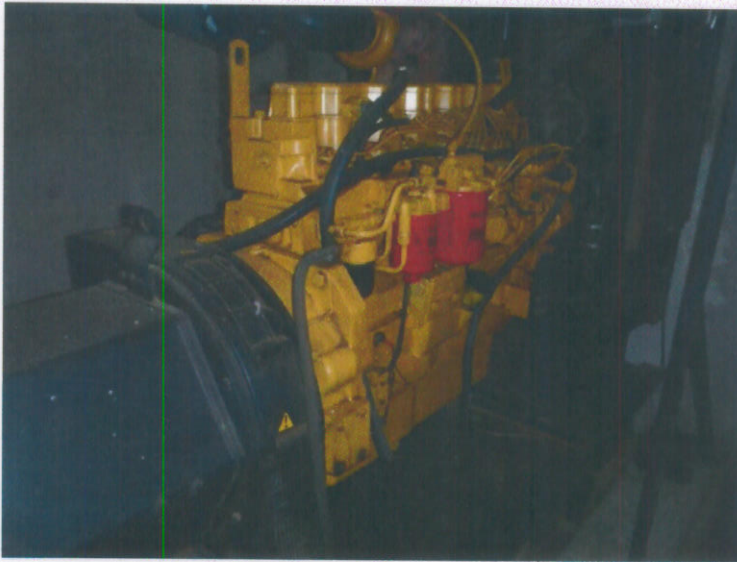
Standby generator (not FEMA generator) is located indoors in a room adjacent to the kitchen. Generator is in fair condition.

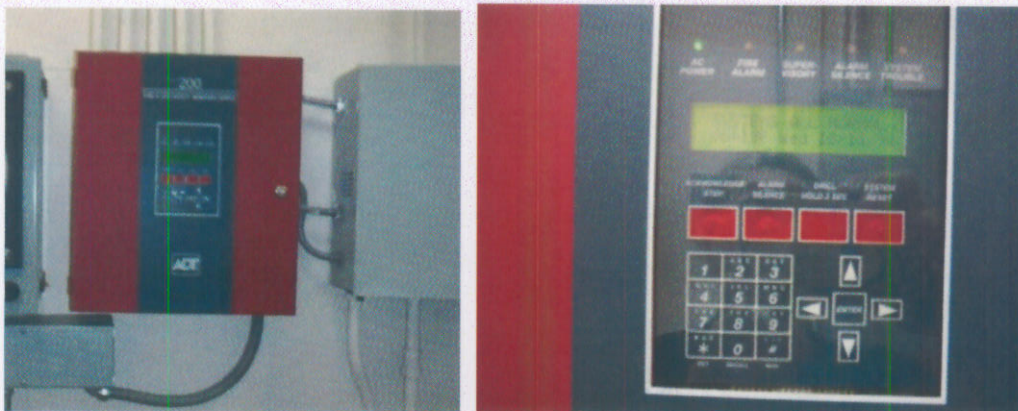
F. Lockhart Elementary School  
1. Fire alarm system

OIA Phase II survey found the fire alarm devices were inadequate. Since the Phase II assessments, the fire alarm was upgraded and now is in good operable condition.. The time and date of the fire alarm panel was inaccurate and should be corrected and be upgradable for future voice communication.

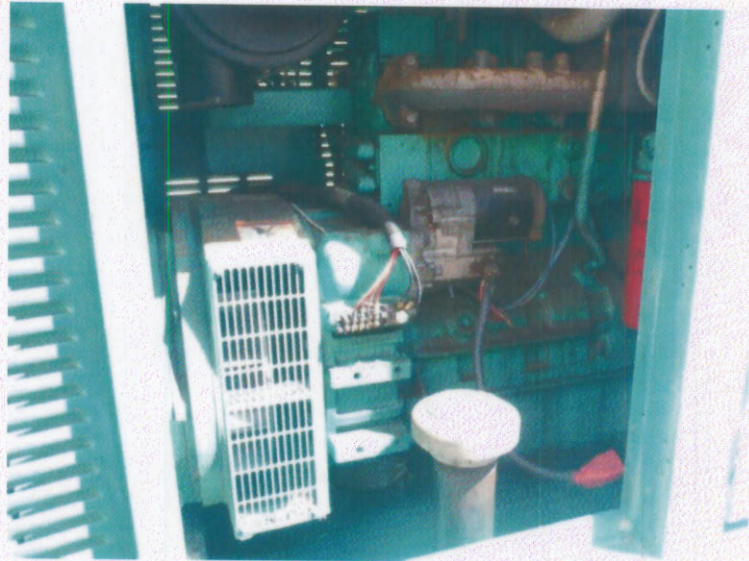
## 2. Electrical system

Standby Generator (not FEMA generator) is in fair condition, but battery is missing

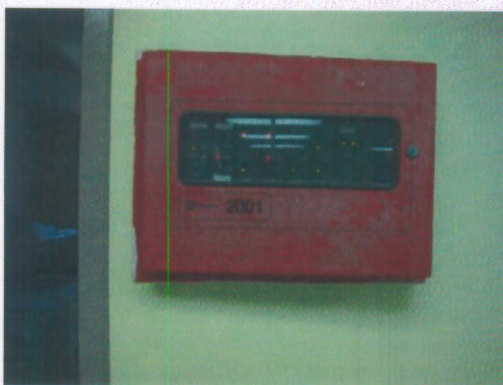
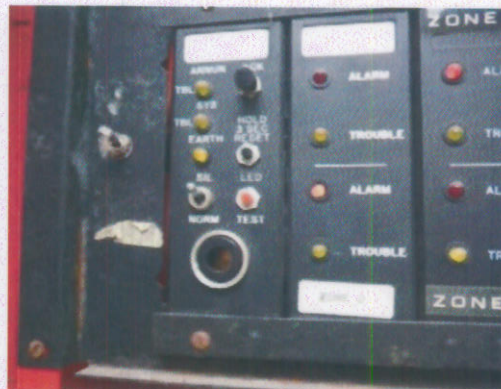
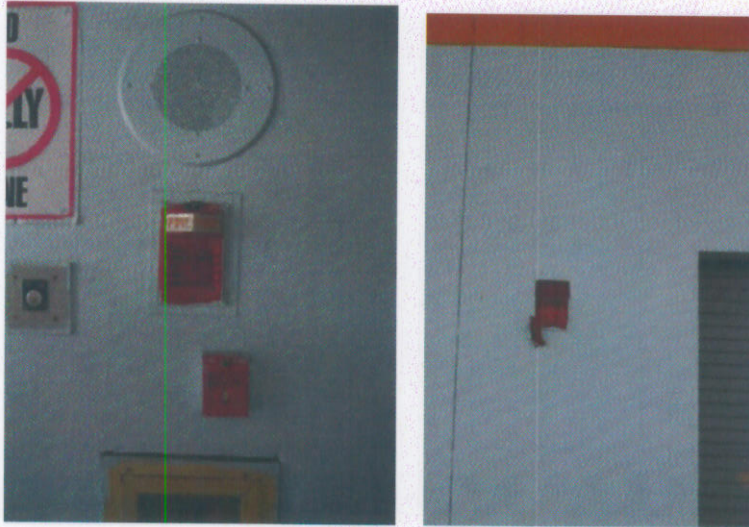
#### 1. Fire alarm system

OIA Phase II survey found the fire alarm system was inoperable. The fire alarm was still inoperable at the start of Phase III. Fire alarm panel was silenced and had numerous trouble and alarm signals. Defected manual pull stations and fire alarm devices need to be repaired or replaced. These pose safety hazards to occupants. Fire alarm system should be serviced and repaired and be upgradable for future voice communication.

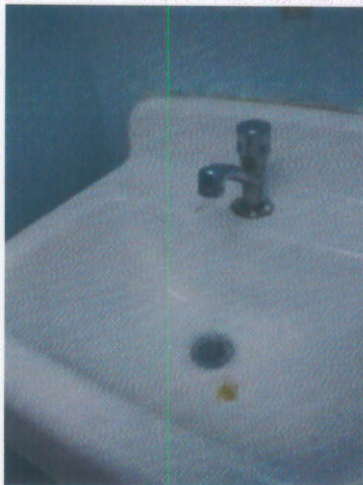
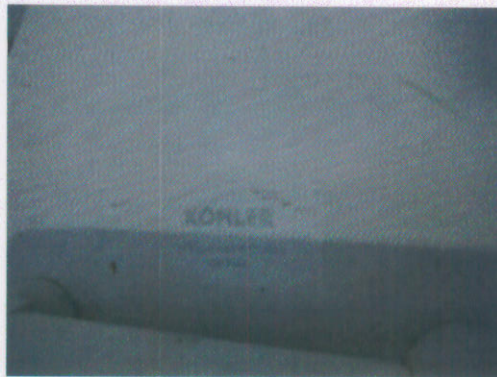
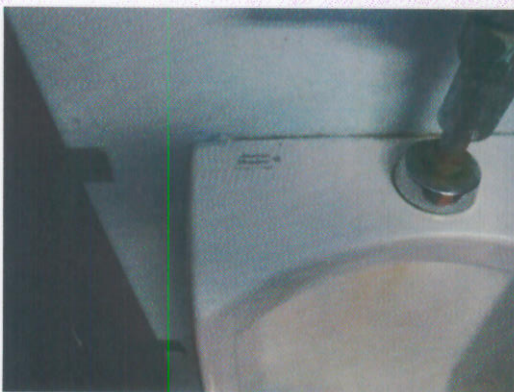
## 2. Low flow plumbing fixtures

Low flow fixtures were installed in portion of the school. At Building 01, push button faucets with aerators and 1.28 gallon per flush (gpf) water closets were installed. However, urinals were 1.0 gpf.

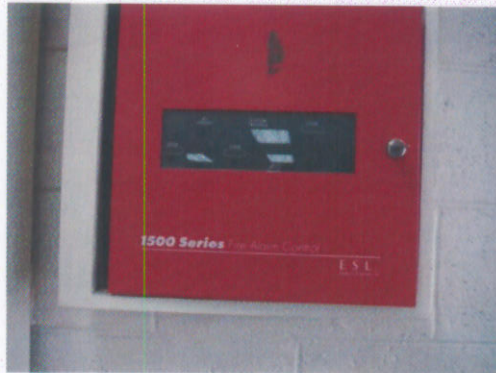
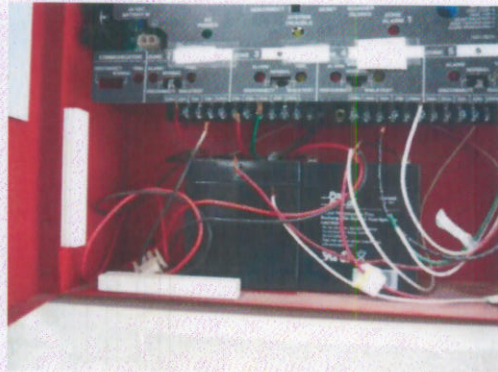
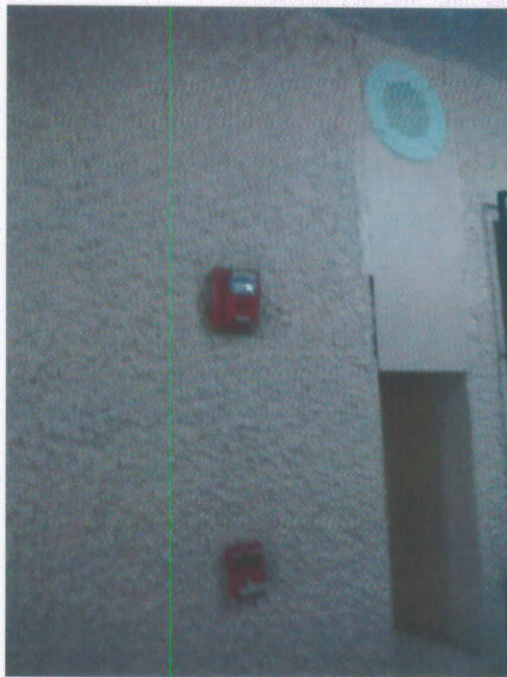
H. John Woodson Junior High School  
1. Fire alarm system

OIA Phase II found the fire alarm system was inoperable. At the start of Phase III, the fire alarm system remained inoperable. Fire alarm panel power was off, wires were removed from the fire alarm panel terminals, and batteries were disconnected. Defected manual pull stations were not repaired or replaced. These are safety hazards to the occupants. Fire alarm system should be serviced and repaired and be upgradable for future voice communication.

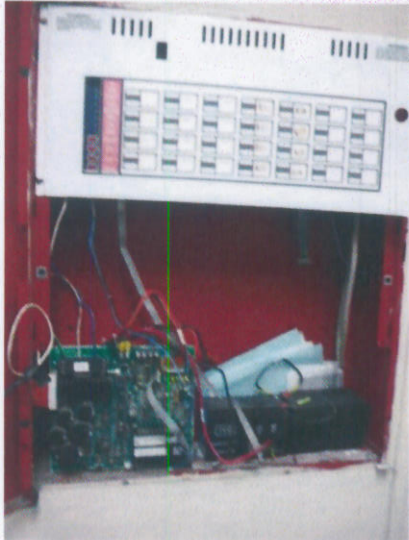
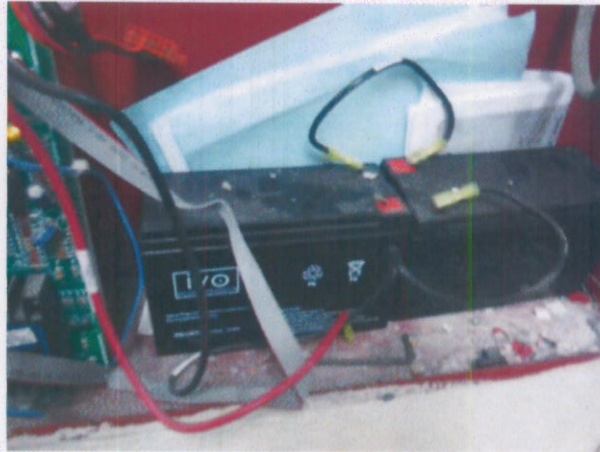
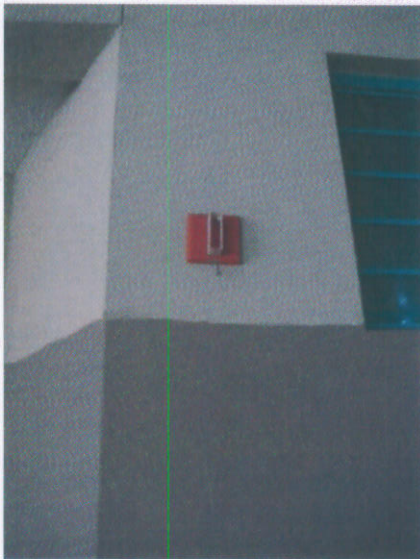
I. St. Croix Education Complex  
1. Fire alarm system

OIA Phase II found the fire alarm systems were inoperable. At the start of Phase III, fire alarm systems were still inoperable. Power to the fire alarm panels were off, batteries were disconnected, and defected fire alarm devices were not repaired. These are safety hazards to the occupants. The fire alarm system should be serviced and repaired and be upgradable for future voice communication.

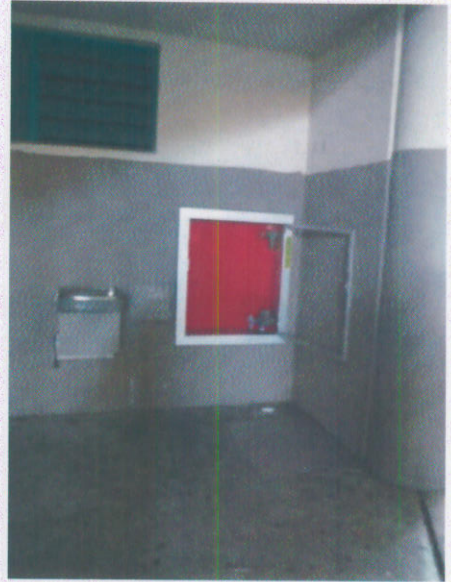
2. Fire pump, fire sprinkler and standpipe system

OIA Phase II found the fire pump, fire sprinkler and standpipe systems required service and repair. At the start of Phase III, no service and repair work had been completed for fire sprinkler and standpipe systems. These pose safety hazards to the occupants. Fire pump, fire sprinkler and standpipe systems should be serviced and repaired.

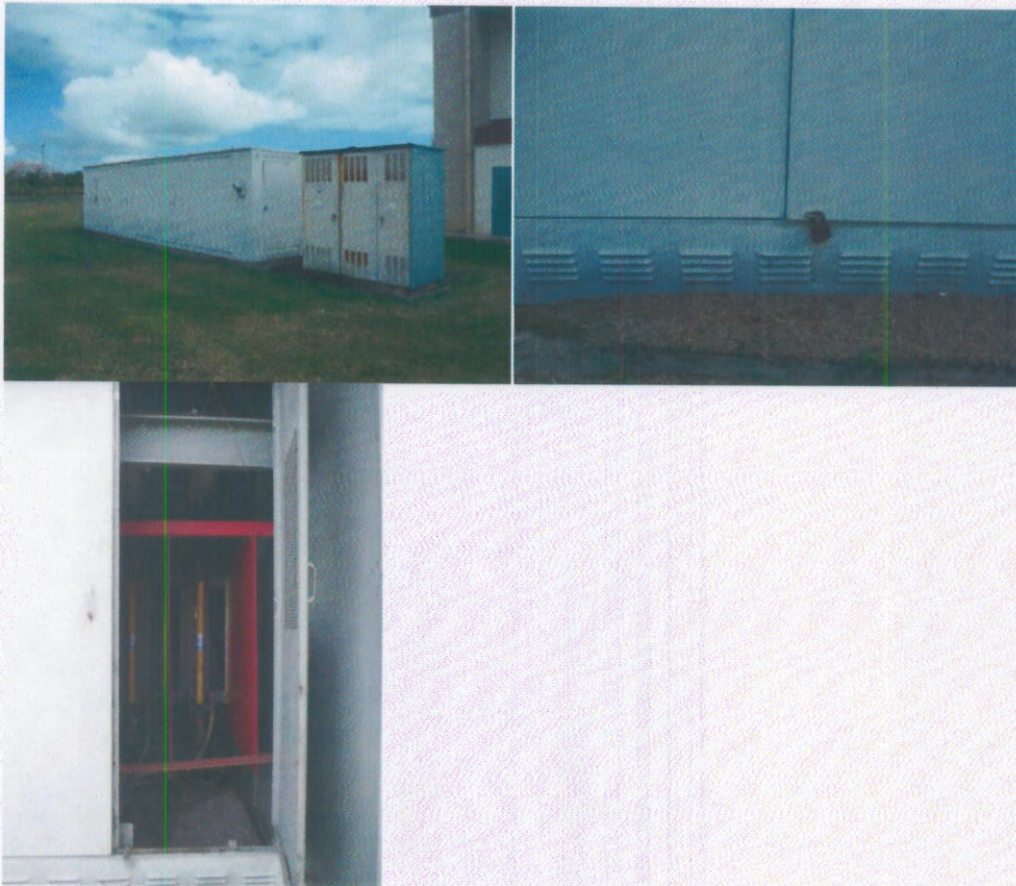
3. Electrical system

Main distribution equipment located outdoors in outdoor enclosures are in satisfactory condition. However, equipment enclosures were not locked exposing live electrical parts if opened.

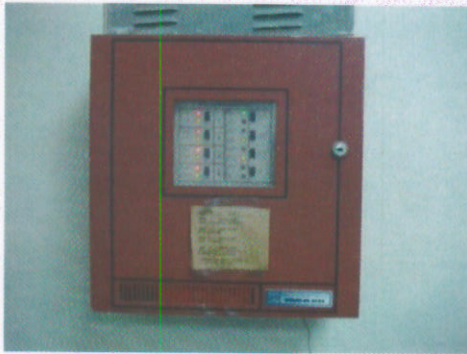
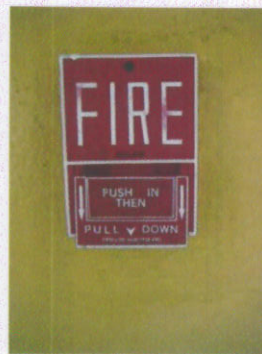
### 1. Fire alarm system

OIA Phase II found the fire alarm system was inoperable. At the start of Phase III, fire alarm system remained inoperable. Fire alarm panel had numerous trouble and alarm signals. Defected manual pull stations were not repaired or replaced. These pose safety hazards to the occupants. Fire alarm system should be serviced and repaired and be upgradable for future voice communication.

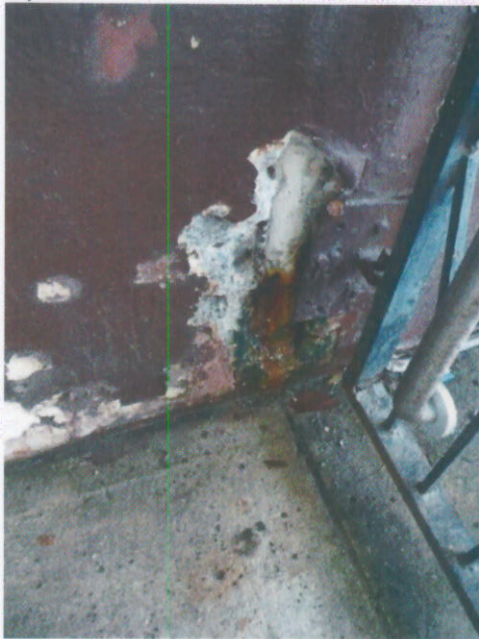
### 2. Building 01

At the time of the initial Phase III site visit, the encased down spout was leaking and needed repair.

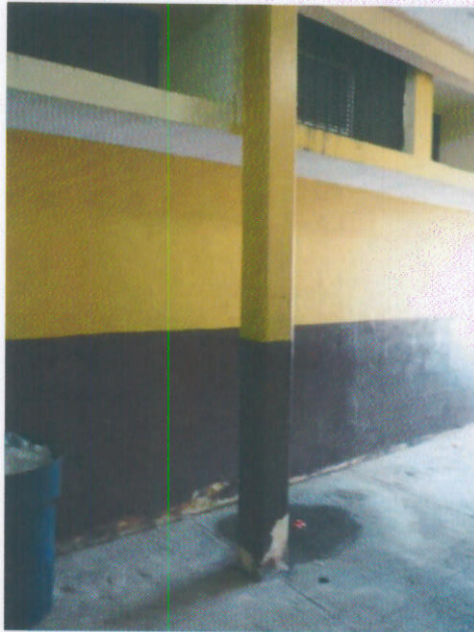
3. Air conditioners' condensate drain

Air conditioners' condensate drains discharged or dripped to the walkway. These are creating slipping hazards as well as damaging the walkway surface. Condensate drain should be piped and discharged to proper location, such as waste line or dry well.

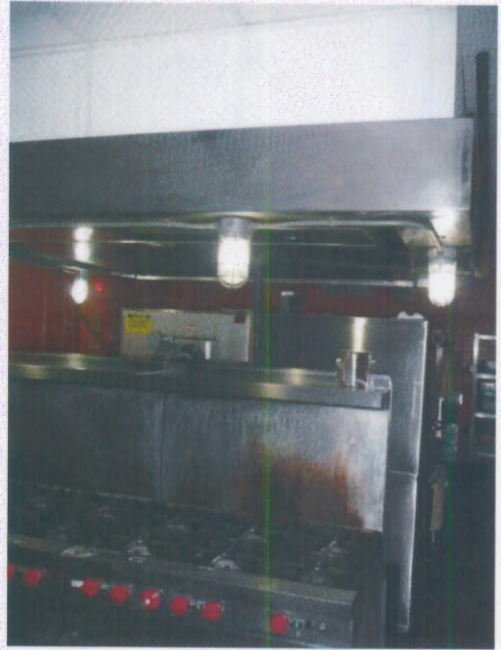
OIA Phase II found that the kitchen hood lacks a fire suppression system. At the start of Phase III, kitchen was being upgraded with new appliances under VIEO's Energy Saving Performance Contract (ESPC). Kitchen hood fire suppression system was not included in the ESPC scope. Lack of fire suppression to the kitchen hood is a fire safety hazard. We recommend including the kitchen hood fire suppression system in the upcoming ESPC.

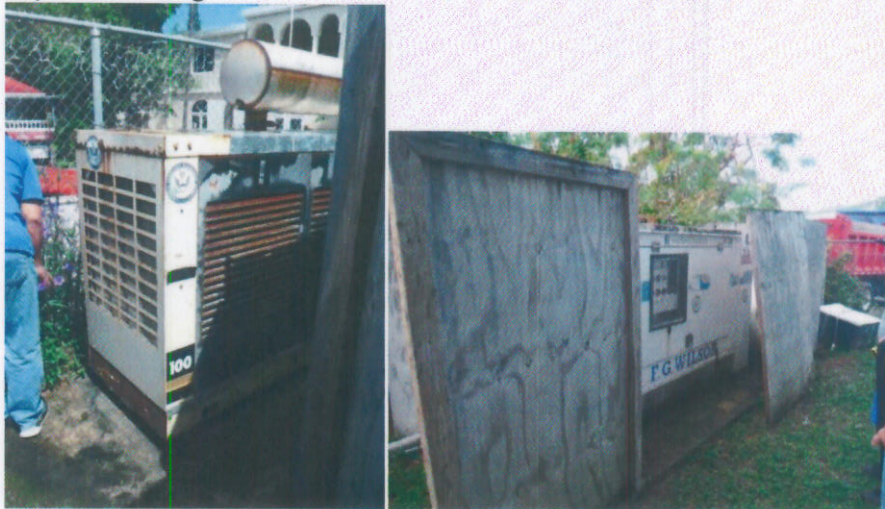
A 100kW FEMA generator is located at main campus. A 72kW FEMA generator is located at the annex building. Both generators are in fair condition but the 72kW generator doesn't start and requires servicing.

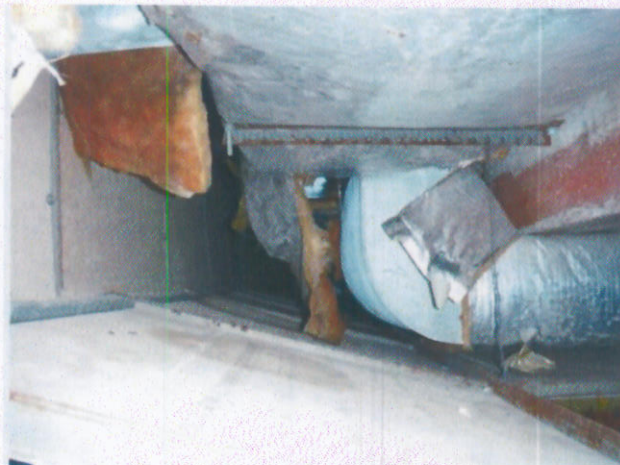
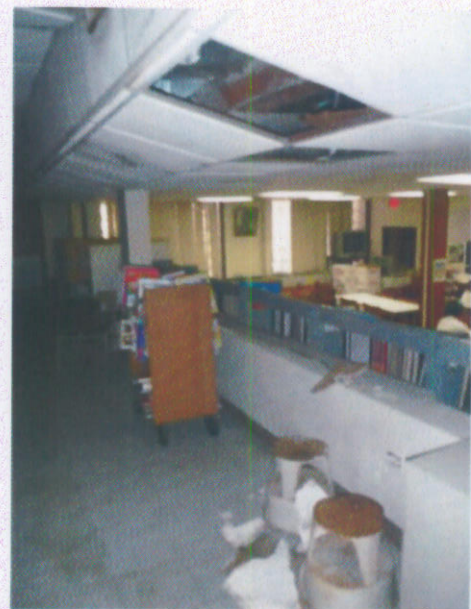
Roof leaks damaged insulation of air ducts. Subsequently, condensation occurred on air ducts and aggravated ceiling damage and high indoor humidity issues.

- Repair air conditioning deficiencies in timely manner. Repair water leaks and condensation as soon as possible.
- Maintain inadequate outside air and space comfort levels to the occupied spaces per ASHARE standards.

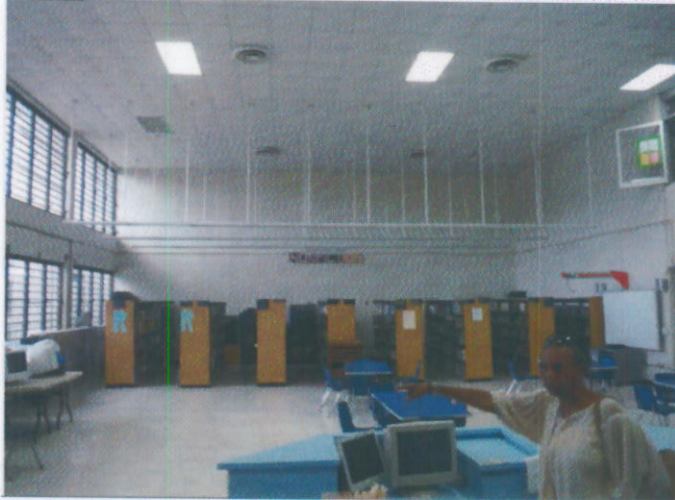
Location: E. Christian JH Building 02, Classrooms & Library

Air conditioners were broken at Library. Library was closed due to high room temperature and humidity.

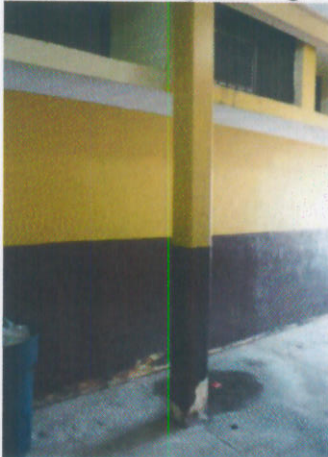
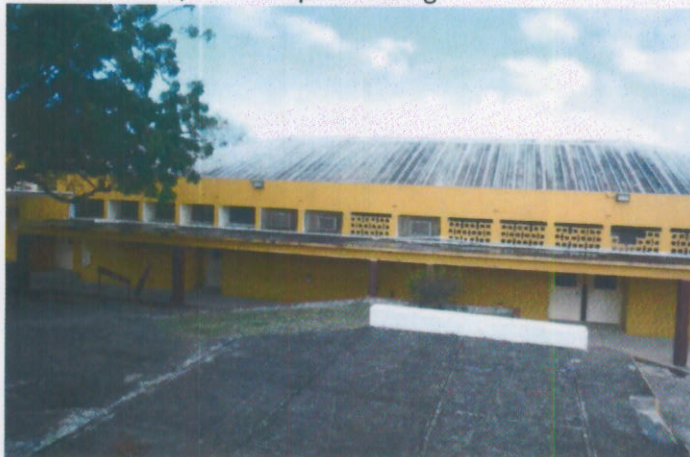
Condensate drains discharged to sidewalks and overhung eaves. They caused slipping hazards and promote vegetation growth at the eaves, which impact roofing.

- Provide proper sized and sloped condensate drain lines to collect and convey the condensate drain. Minimum 1" (25 mm) diameter pipe and 2% slope are preferred. Provide clean out not more than 180 degree change in direction and 50 ft apart.
- Condensate drain should discharge to dry well or indirect drain with P-trap to waste line.

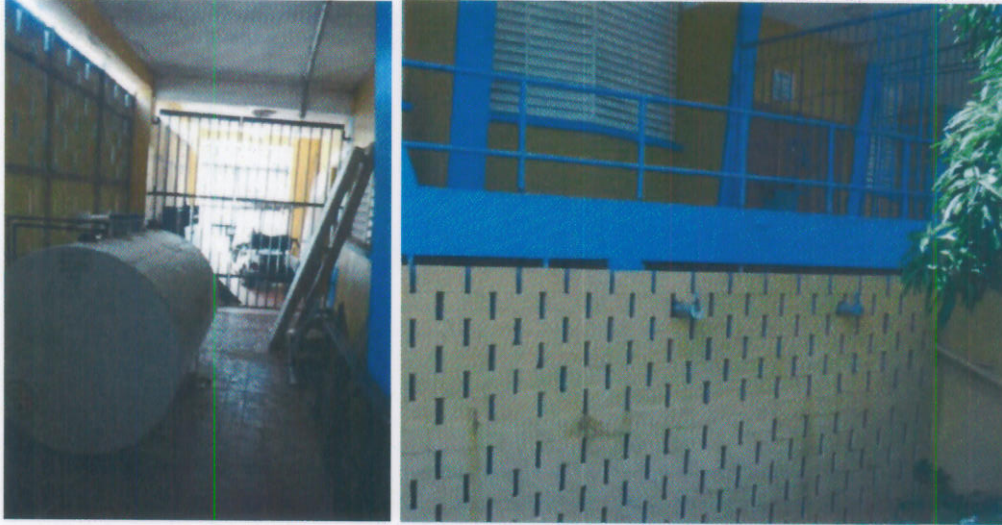
Normal vent and emergency vents of aboveground fuel tank were not piped to outside per IFC requirements. Generator engine exhausts terminated by the sidewalk did not comply with IMC and IFC, and posted safety and health hazard to occupants.

- Require qualified engineer and technician to install and commission the standby generator system.
- Install and commission system in accordance with applicable codes and standards, and manufacturer requirement and recommendations.
- Consult with fire department for generator and fuel system installation requirements.

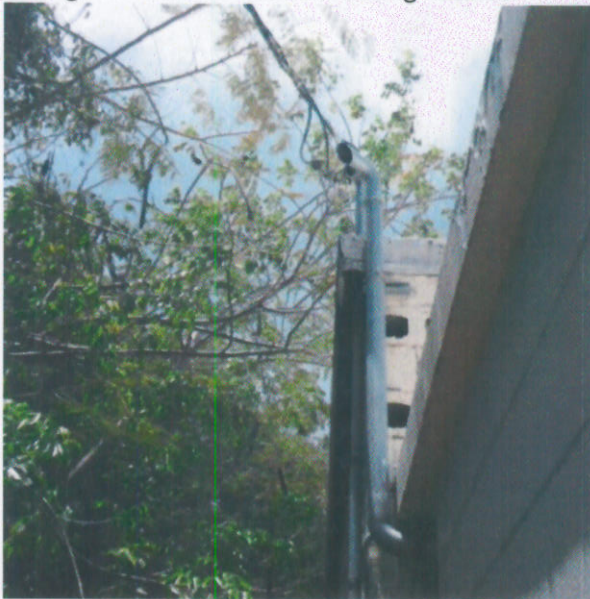
Location: Claude O. Markoe ES Building 2, Storage

Engine exhaust discharged underneath of the utilities cables. Hot engine exhaust fume could damage the cable insulation causing hazards.

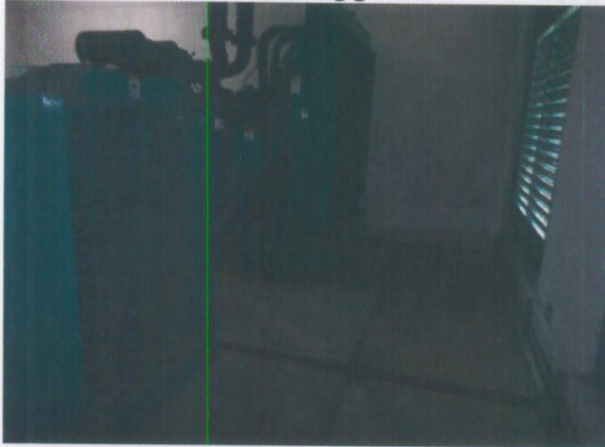
Location: St. Croix Education Complex Building 4, Agriculture / Green House.  
Radiator exhausts were not connected to exhaust louvers. Hot air could not leave the room and recirculate to radiator causing generator overheating and operation problem.

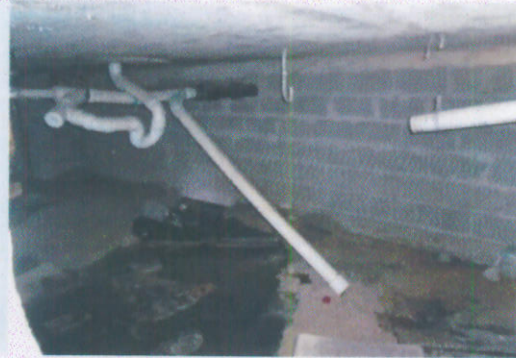
Waste piping was separated due to snapped pipe stripe supports causing waste spilled inside the crawl space.

- Use proper anchor, hanger and pipe support system, such as steel rod, ring hanger, clevis hanger, and trapeze hanger.
- Use corrosion resistant material and coating for pipes and supports at humid and corrosive environment.

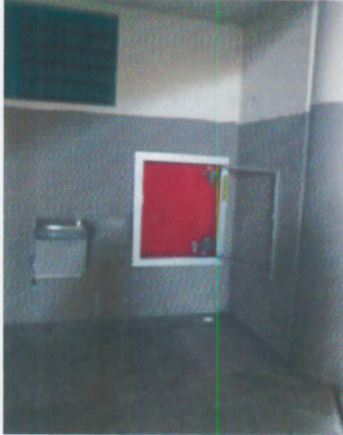
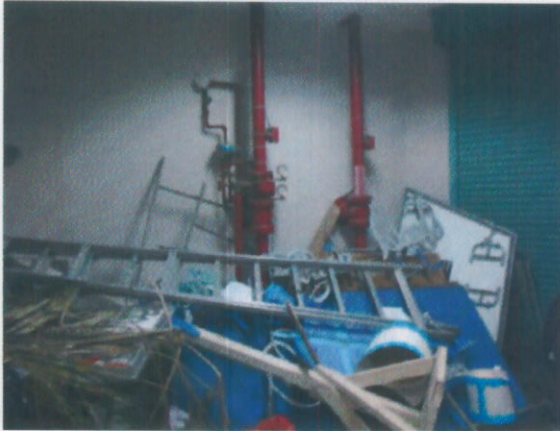
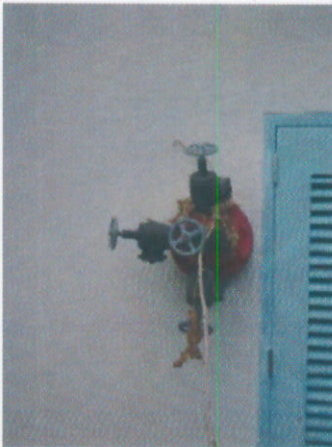
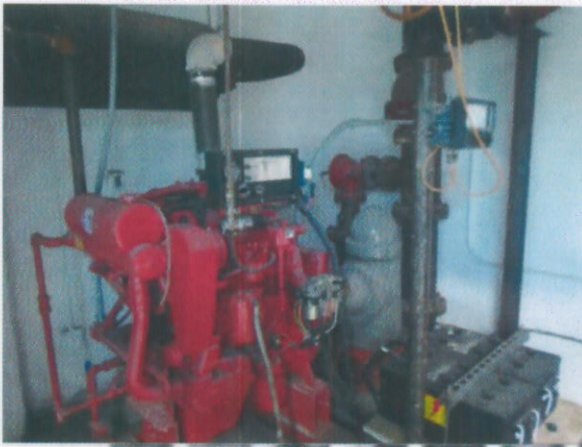
Wet based fire protection systems including fire sprinkler, standpipe and fire pump were not maintained and tested in accordance with NFPA standards. Fire hoses were missing at fire hose cabinets. Sprinkler risers were obstructed by combustible materials. Flow test header and fire pump were not maintained and tested. Fire protection systems are fire and life safety systems to protect the occupants and the properties. They should be maintained and serviced regularly to ensure their functions and performance. They should be repaired as soon as impairment is required.

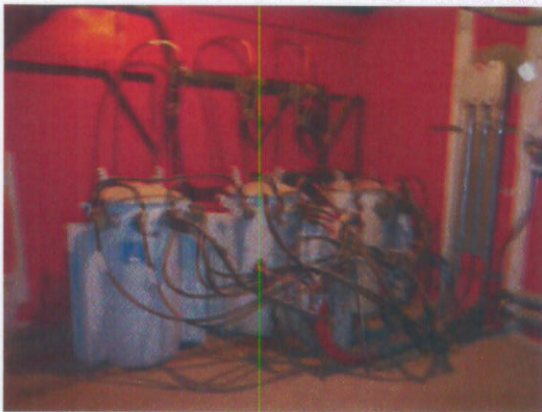
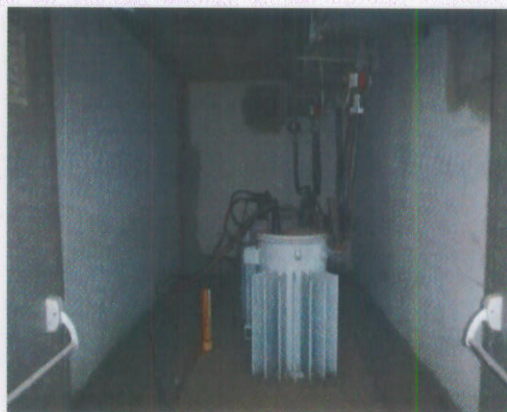
Location: Charlotte Amalie High School and E. Benjamin Oliver Elementary School

Existing transformers are located in a room that is not rated for use as a transformer vault.

- Install new pad mounted exterior transformer and remove existing transformer
- Installation of new pad mounted transformer will require shutdown of electrical services
- Site of new pad mounted transformer will need to be coordinated with WAPA
- Installation requirements per WAPA Standards
