The Government of the Virgin Islands, Department of Property and Procurement is requesting proposals from qualified contractors for the following services: **RFP-016-2018 (P) Architectural Engineering (A/E) Services for the Restoration of 1105 King Street, Government House, Christiansted, St. Croix.**

US VIRGIN ISLANDS PRELIMINARY DISASTER DAMAGE ASSESSMENT REPORT
AND COST ESTIMATE FOR HISTORIC STRUCTURES
GOVERNMENT HOUSE, CHRISTIANSTED, ST. CROIX.

Based on the initial assessments that were conducted by AECOM from 4-9 November 2017, the overall damage to the facility is considered Severe - repairable.

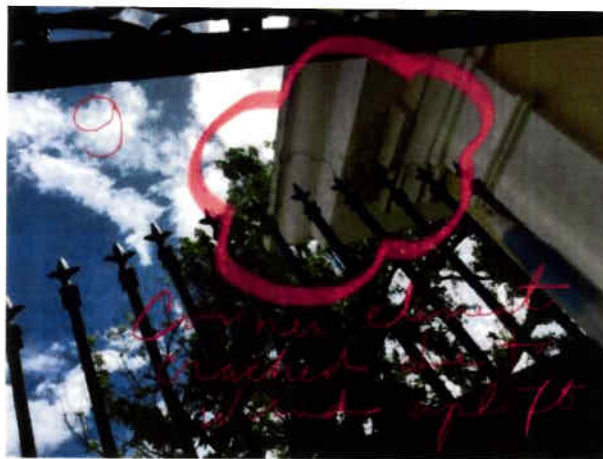
Description: Cracks and water damage along soffit cornice

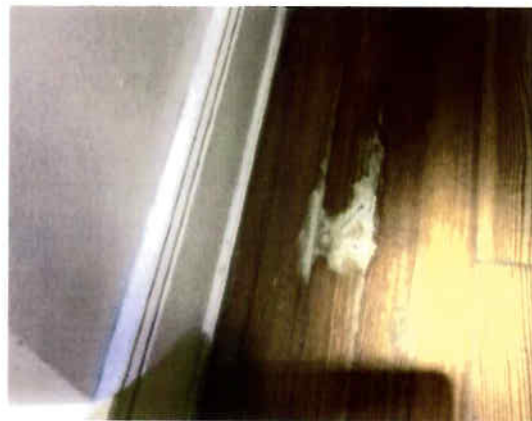
Description: Wood Flooring is water damaged

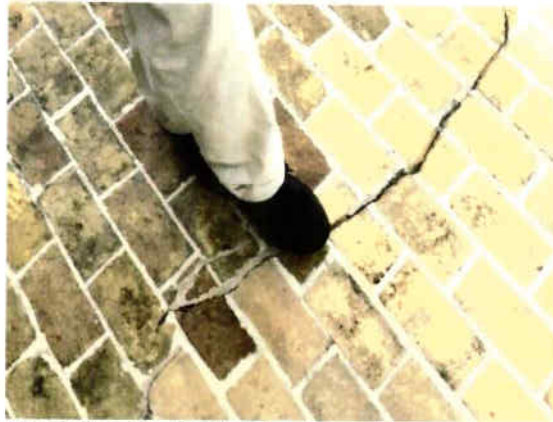
Structural damage was noted in the structural aspects, as 25% of all columns and walkways exhibited cracks and/or settlement.

Description: Structural cracks along walkway

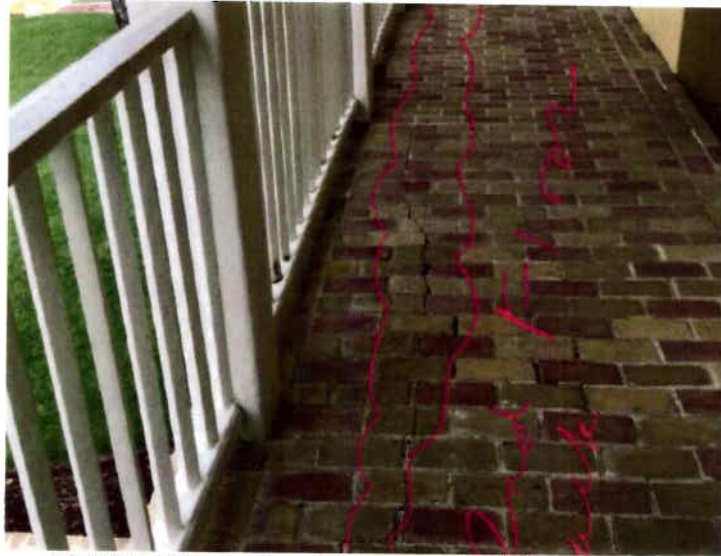
As a result of storm driven rain intrusion and high winds, the concrete masonry and foundation have settled causing cracks. 5 structural elements including column capitals, arches, and walls were cracked along with the second floor exterior walkway.

Description: Structural cracks along upper level of exterior corridor

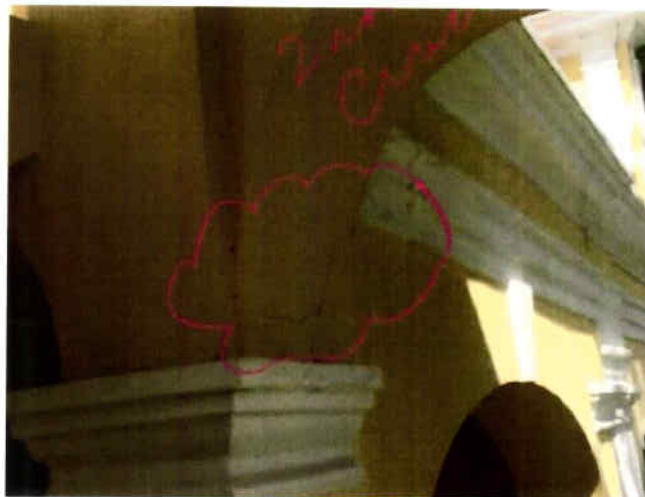
Description: Structural cracks in second floor arch

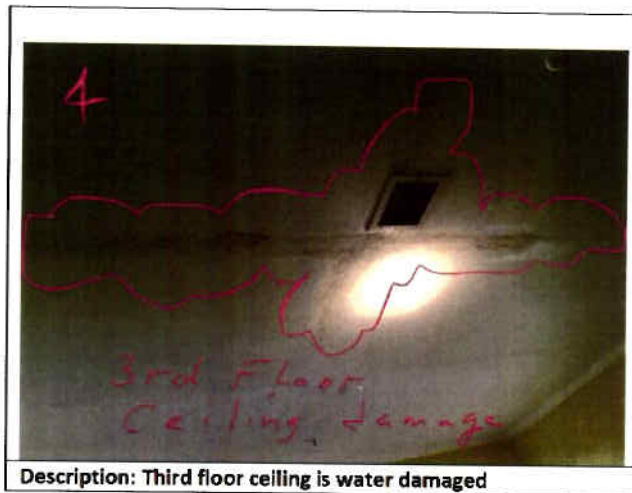
Water damage on the third floor ceiling was noted as there is a possible structural roof leak.

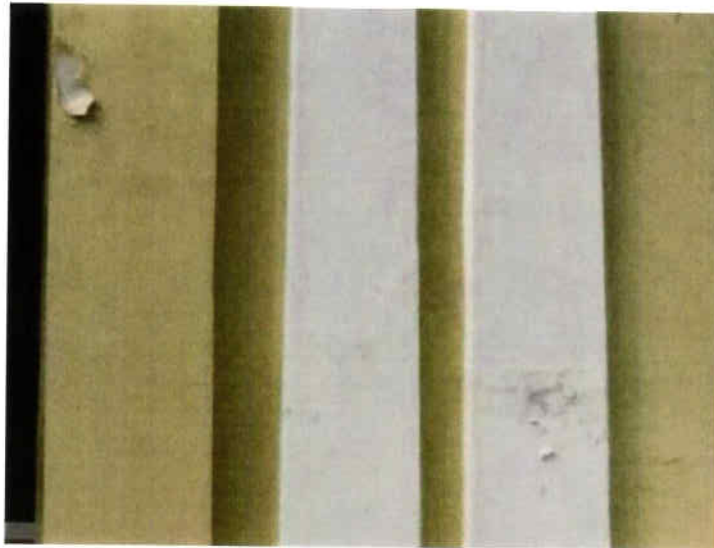
As a result of storm driven rain intrusion and hurricane force windblown debris impact damage, 45% of gypsum plaster interior ceilings and walls will need to be repaired and or restored, 100% of interior walls, ceilings, and trim will need to be repainted, and 45% of interior wood floors will need to be refinished. Some exterior finishes were removed due to the severity of the storm as well.

Description: Damaged paint

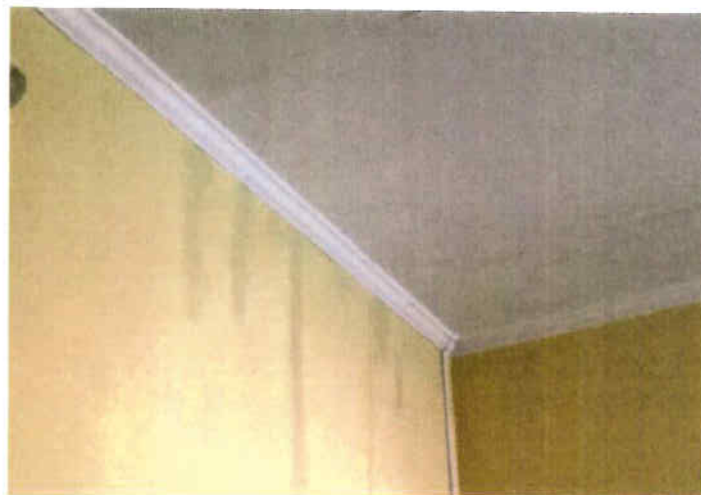
Description: Water damage at wall and ceiling due to water intrusion from above

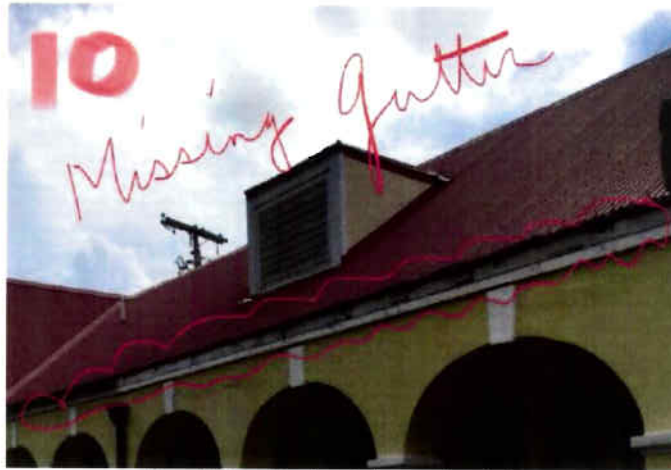
Due to hurricane force windblown debris impact damage, there is significant damage to the roof gutter. 30 ft of gutter has been ripped off of the roof and there is a leak in the roof gutter over the main entrance. The 30 ft of gutter will either need to be repaired or replaced.

Description: Roof metal gutter is missing

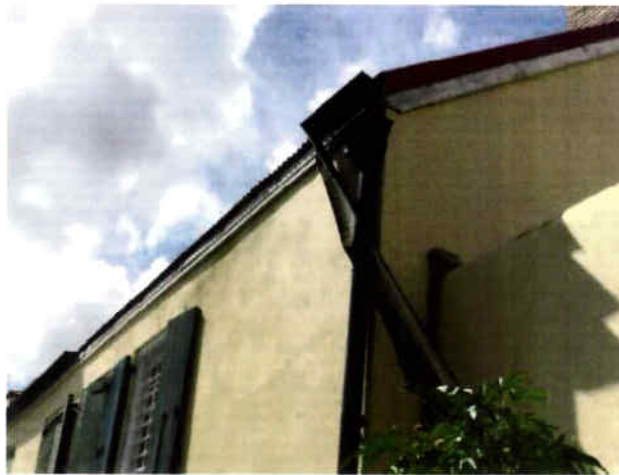
Description: Roof metal gutter is damaged

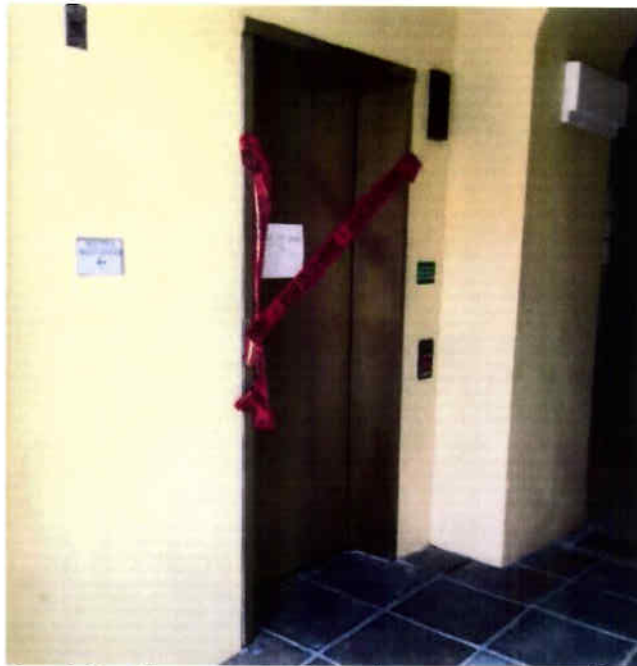
Due to storm driven rain intrusion and hurricane force windblown debris impact damage, 10% of interior enclosed electrical switches and circuit breakers will need to be replaced, 10-25% of all interior lighting fixtures and conduit will need to be replaced, 45-75% of all exterior lighting fixtures and conduit will need to be replaced, and the Emergency Generator was observed to have sustained significant damage and will need to be evaluated for repair and or replacement. The elevator system is non-functional due to water intrusion.

Description: Elevator not functioning due to water intrusion from above
