Preliminary Disaster Damage Assessment

Government House, St. Croix, Frederiksted

315 Prince Street, Frederiksted, St. Croix, 00840

US VIRGIN ISLANDS PRELIMINARY DISASTER DAMAGE ASSESSMENT REPORT
AND COST ESTIMATE FOR HISTORIC STRUCTURES

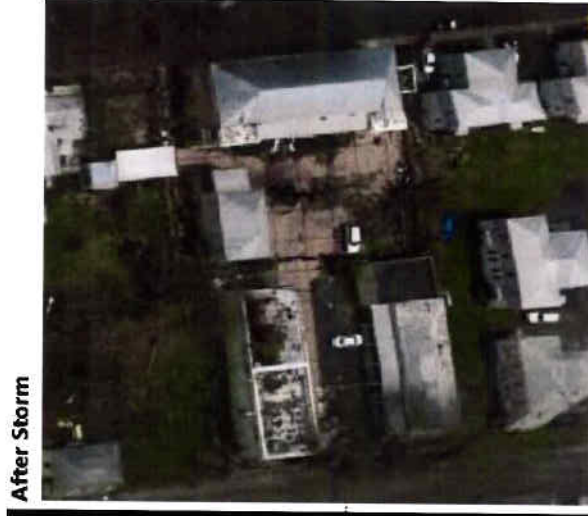
After Storm

Major

Non-Flood: Wind Driven, Roof Damage, Water Intrusion.
Disaster Damage
Brick and stone masonry construction with plaster/stucco exterior and corrugated metal roof.

Discipline	Mechanical/Plumbing	Electrical / Comm/ Security	Fire Protection	Overall Narrative Rating
Architecture Exterior: Overall significant damage. Roofing- majority of gutter and downspout drainage system have been damaged or blown-off due to high wind event. Resealing of all existing roof corrugated metal deck laps joints and flashings required. HAZMAT materials verification recommended prior to any scope of work performance. Wall(s)-portion of existing stucco has been damaged or blown-off due to high wind event. Repainting of exterior facade/ walls areas required. Recommendation for crack/stucco/ waterproofing/ paint for exterior building envelope walls. Replacement of existing broken window/glazing required. Interior minor damages. Plaster, wood trim and paint damaged by water penetration, some mold is present.	Plumbing systems have moderate to catastrophic damage. Plumbing fixtures require moderate repairs or replacement but roof gutter system has substantial damage and leaks. Mechanical has moderate damage to generator exhaust.	Electrical conduits and wiring of branch circuits have been affected. Exterior lighting fixtures have been affected. Exterior disconnect switches have been affected. All need complete replacement.	Some devices damaged, require further inspection.	Severe but repairable - Remediation efforts that will be necessary as a result of roof damage includes replacement of a significant portion of all partitions and building systems.

Structure Minor Damage. Minor wall cracks in second floor and meeting house. Some minor water damage to architectural finishes due to roof leaks.

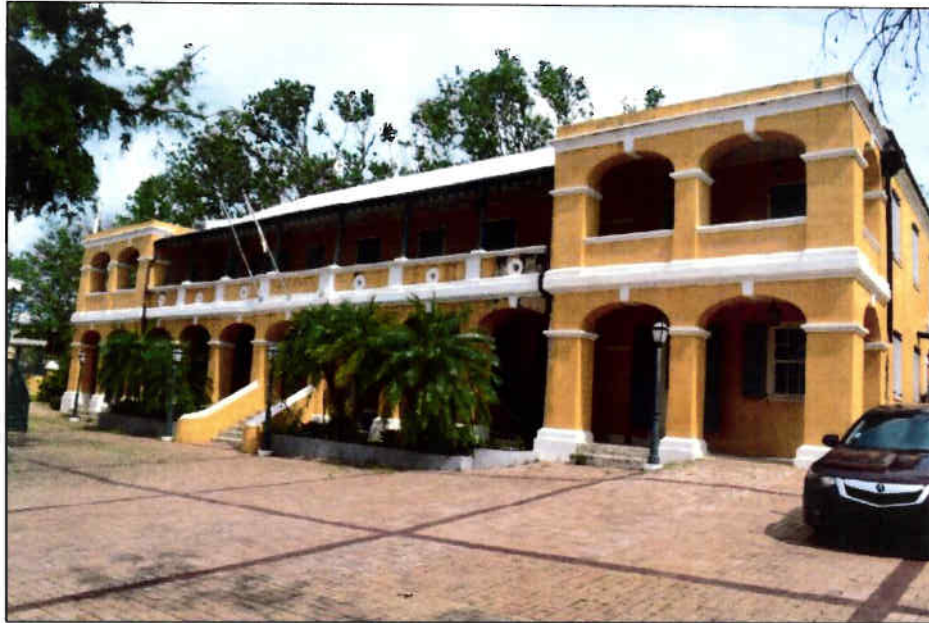
Figure 1: Danish School, Front (West) Elevation, Looking Northeast. Taken 11/7/2017.

- Exterior: to the extent exterior stucco (Figure 1) needs repair, care should be taken in the removal of the damaged stucco so as not to dislodge load-bearing rocks or bricks, creating large holes that need to be rebuilt. Repairs to shutters, windows, or sections of the roof will probably affect modern replacement materials. One of three non-historic flag poles over the main entrance stair (Figure 2) was destroyed by falling debris.

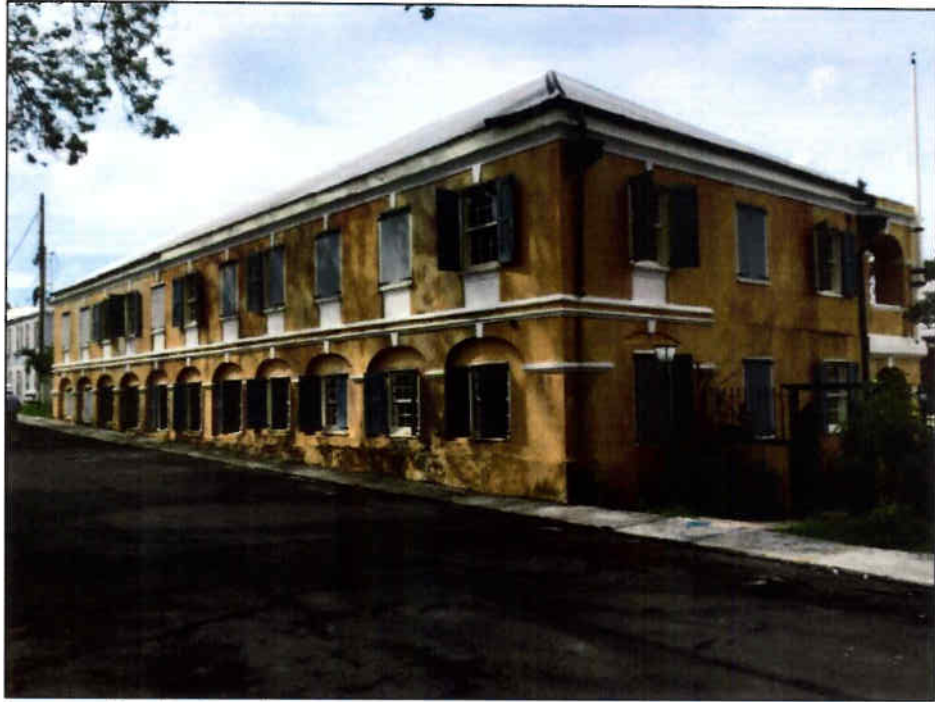
Figure 2: Danish School, Rear (East) and Side (North) Elevations, Looking Southwest. Taken 11/7/2017.

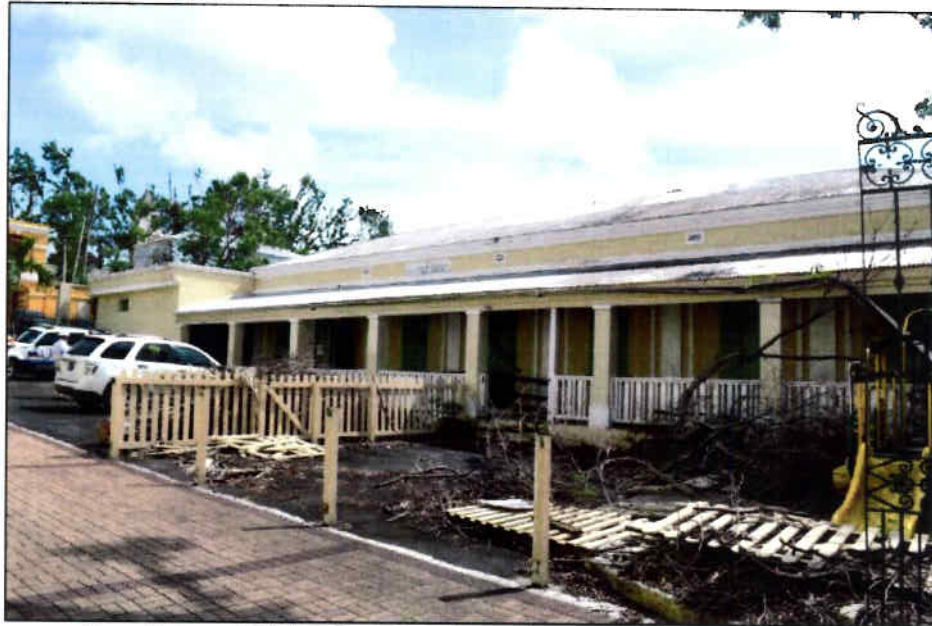
Figure 5: Annex Building, North Elevation, Looking Southeast. Taken 11/7/2017.

- The addition on the east end of the Annex Building has a small breezeway that connects the restrooms, storage room, and utility room to the gallery along the front (north) of the building. The non-load-bearing concrete wall on the south end of the breezeway has cracked and is separating from the two adjoining structures (Figure 5).

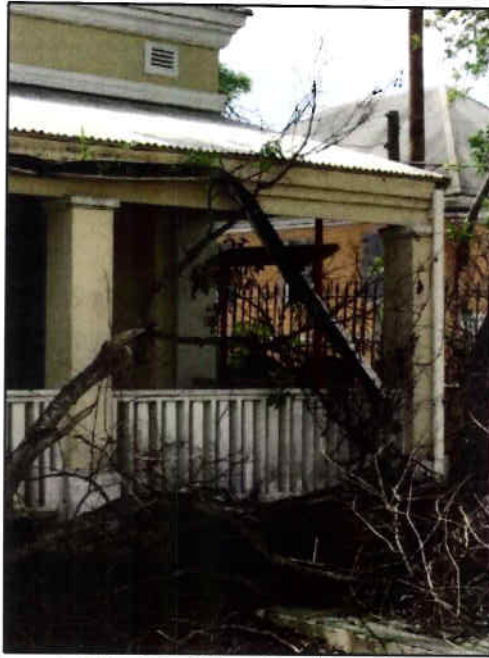
The facility sustained hurricane force winds that caused significant damage, the majority of metal roof gutters and downspouts were missing or damaged by high windblown debris impact.

Figure 6: Annex Building, North Elevation, damaged gutter. Taken 11/7/2017.

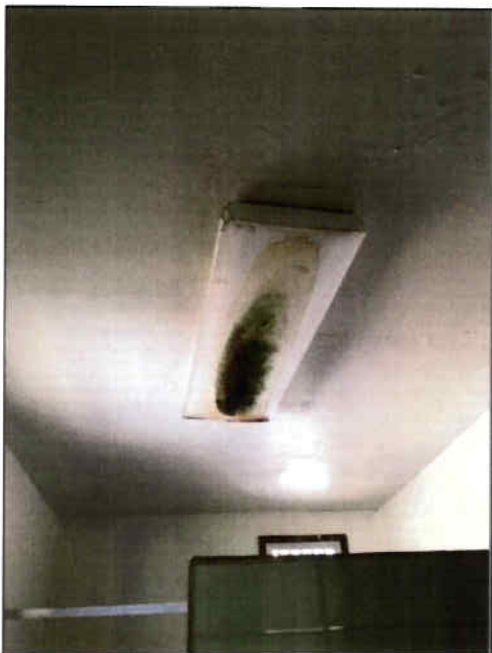
Figure 7: (Left) Annex Building, Detail of Water/Mold Damage to light fixture. Taken 11/7/2017.

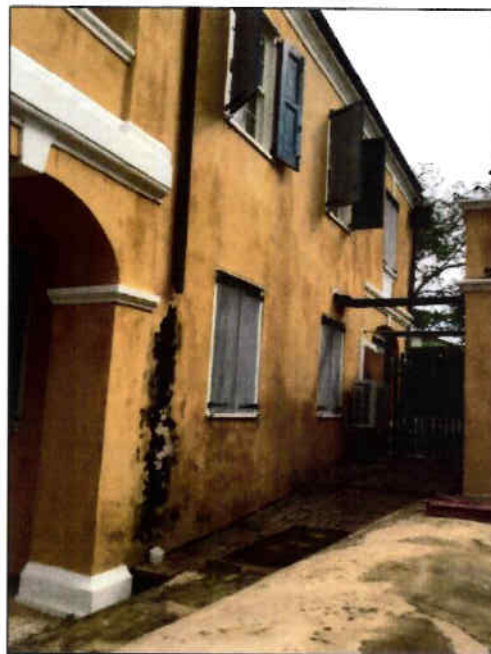
Figure 8: (Right) Danish School Building, Detail of Water/Mold Damage to Exterior Stucco, Southwest Corner, Looking Northeast. Taken 11/7/2017.

As a result of storm driven rain water intrusion, 25% of the facility will required mold remediation and 25% of mold damaged material will need to be removed and disposed. In some cases restoration vs replacement will be required due to the historic nature of this structure. Plaster and wood can be cleaned and treated rather than removed and disposed. As most interior finishes are not original, materials may be removed and replaced in-kind.

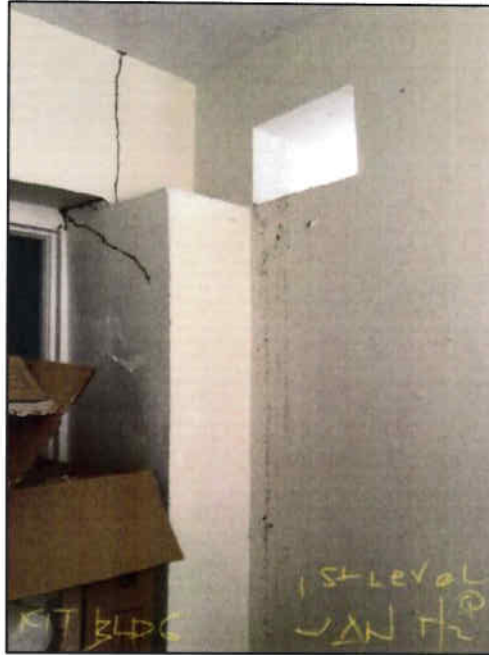
Storm water saturated earth caused subterranean termites to migrate and invade building areas.

Figure 9: Detail of Termite Trail in Ground Floor, Kitchen. Taken 11/7/2017.

- Exigent Repairs Required
 - The Kitchen exhibits evidence of termite activity (Figure 7), especially in the ground floor. All three buildings in the complex should be checked for termite activity and the Kitchen, in particular, should be treated either before or at least concurrently with other repairs. When repairing any termite damage, care should be taken to retain as much of the historic wood as possible. In the case of the kitchen, the second floor is of modern construction, so replacement of termite-damaged materials should be in-kind.

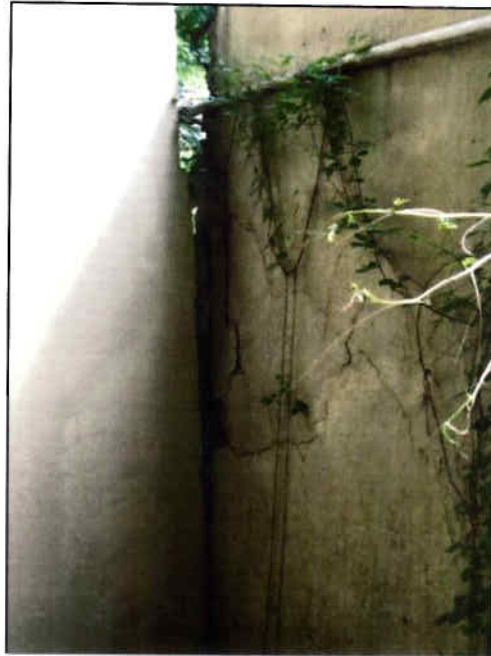
As a result of hurricane force winds, five exterior walls suffered minor cracks at the second level of the main building, the meeting house and Annex Building. Repairs should be made with in-kind material that is the same hardness as the surrounding plaster coat to meet *SOI Standards*.

Figure 10: Detail of a Large Crack in the Annex Building's Breezeway Concrete Wall, Looking South. Taken 11/7/2017.

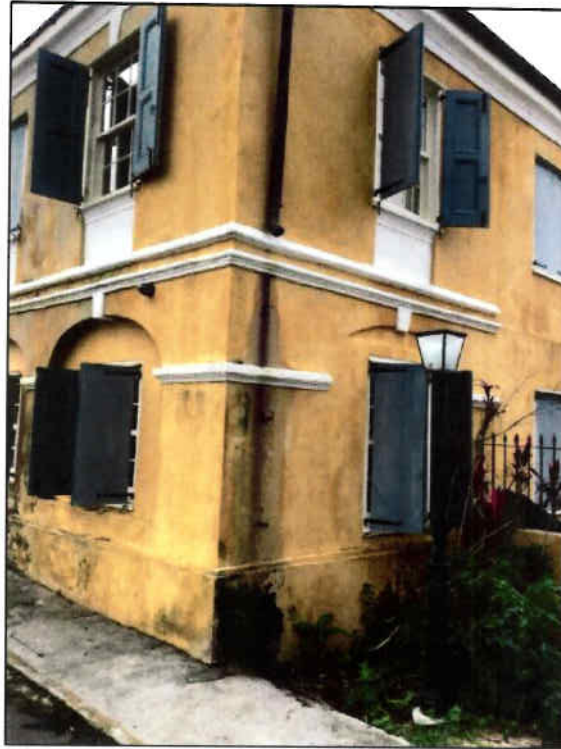
As a result of hurricane force winds the majority of metal roof gutters and downspouts were missing or damaged. To meet *SOI Standards*, replacement materials should match existing materials, design, dimensions, etc.

Figure 11: Danish School, Rear (East) and Side (North) Elevations, damaged gutter and wood panels. Taken 11/7/2017.

As a result of Hurricane force winds and debris impact damage, 10% of exterior doors were damaged and will to be replaced or restored and 45% of exterior wood shutters and aluminum windows will need to be replaced or restored. These materials are not original to the building, but were installed in a restoration/reconstruction project that met *SOI Standards*, based on historic drawings and photos. If replacement is required, new materials should be in-kind. Refer to figure 11.

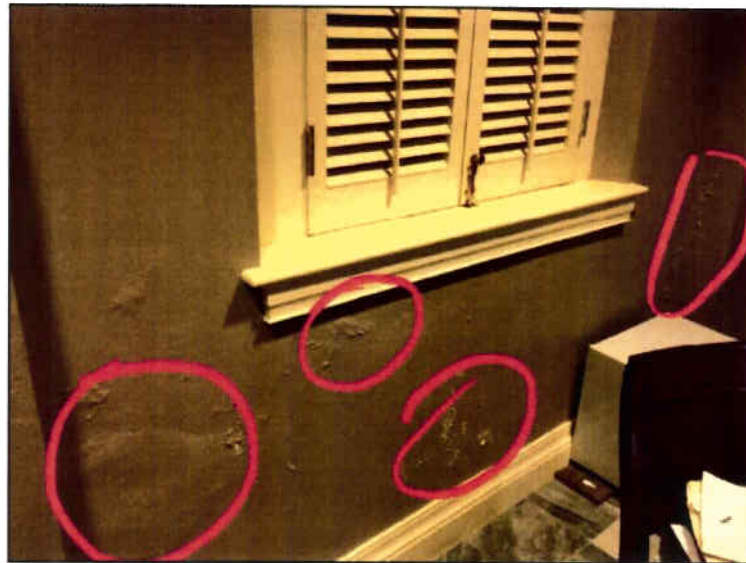
Figure 12: Detail of an Example of Interior Plaster Damage due to Water/Moisture Infiltration. Taken 11/7/2017.

Due to wind driven rain intrusion, interior ceiling and wall plaster will need to be repaired and or restored. Interior walls, ceilings and trim will need to be repainted. Non-permeable paint may not be appropriate for use in replacement of the existing paint finish on plaster surfaces, since it traps water—a cured lime wash may be required to meet *SOI Standards*.

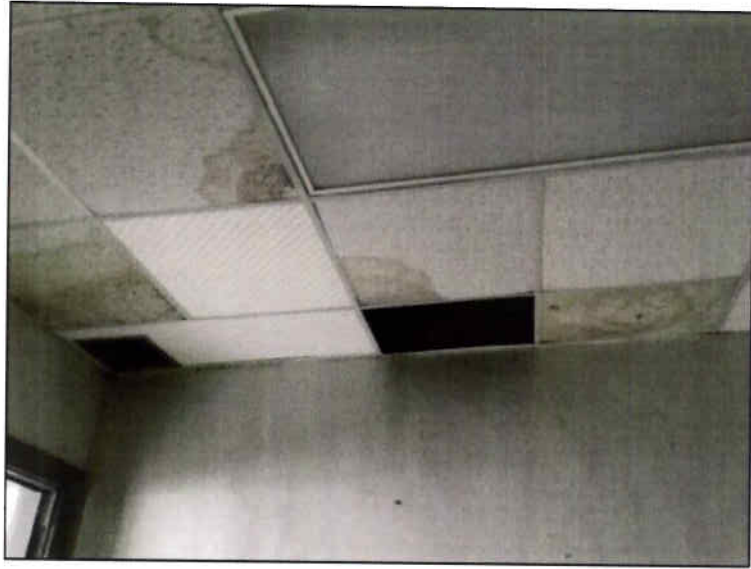
Figure 13: Detail of Multiple Roof Leaks in Annex Building, Exacerbated By Wind-Driven Rain, Looking West. Taken 11/7/2017.

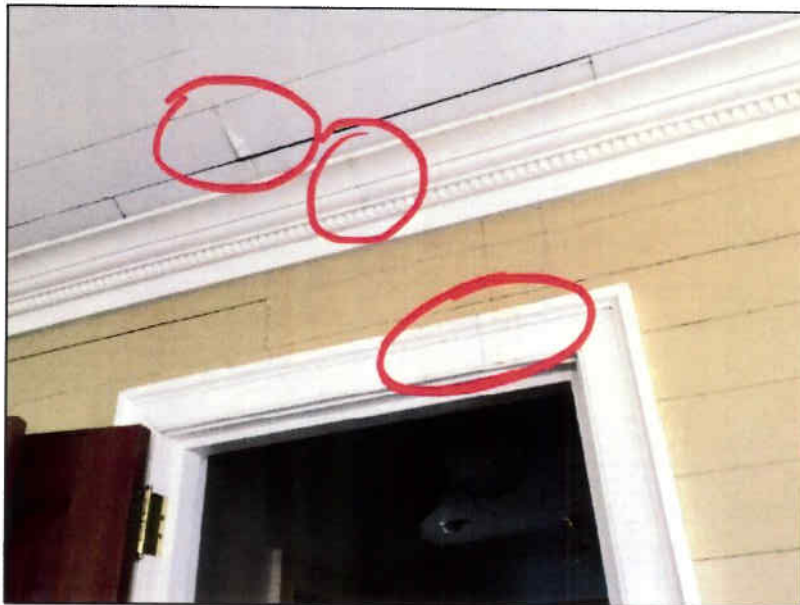
Figure 17: Detail of an Example of Water Infiltration from Room Showing Warped Wood Planks in Ceiling and Staining from Water Dripping. Taken 11/7/2017.
