OIA – ASSESSMENT OF BUILDINGS AND CLASSROOMS
US VIRGIN ISLANDS – ST. THOMAS

YVONNE E. MILLINER-BOWSKY ELEMENTARY SCHOOL

FIGURE 15

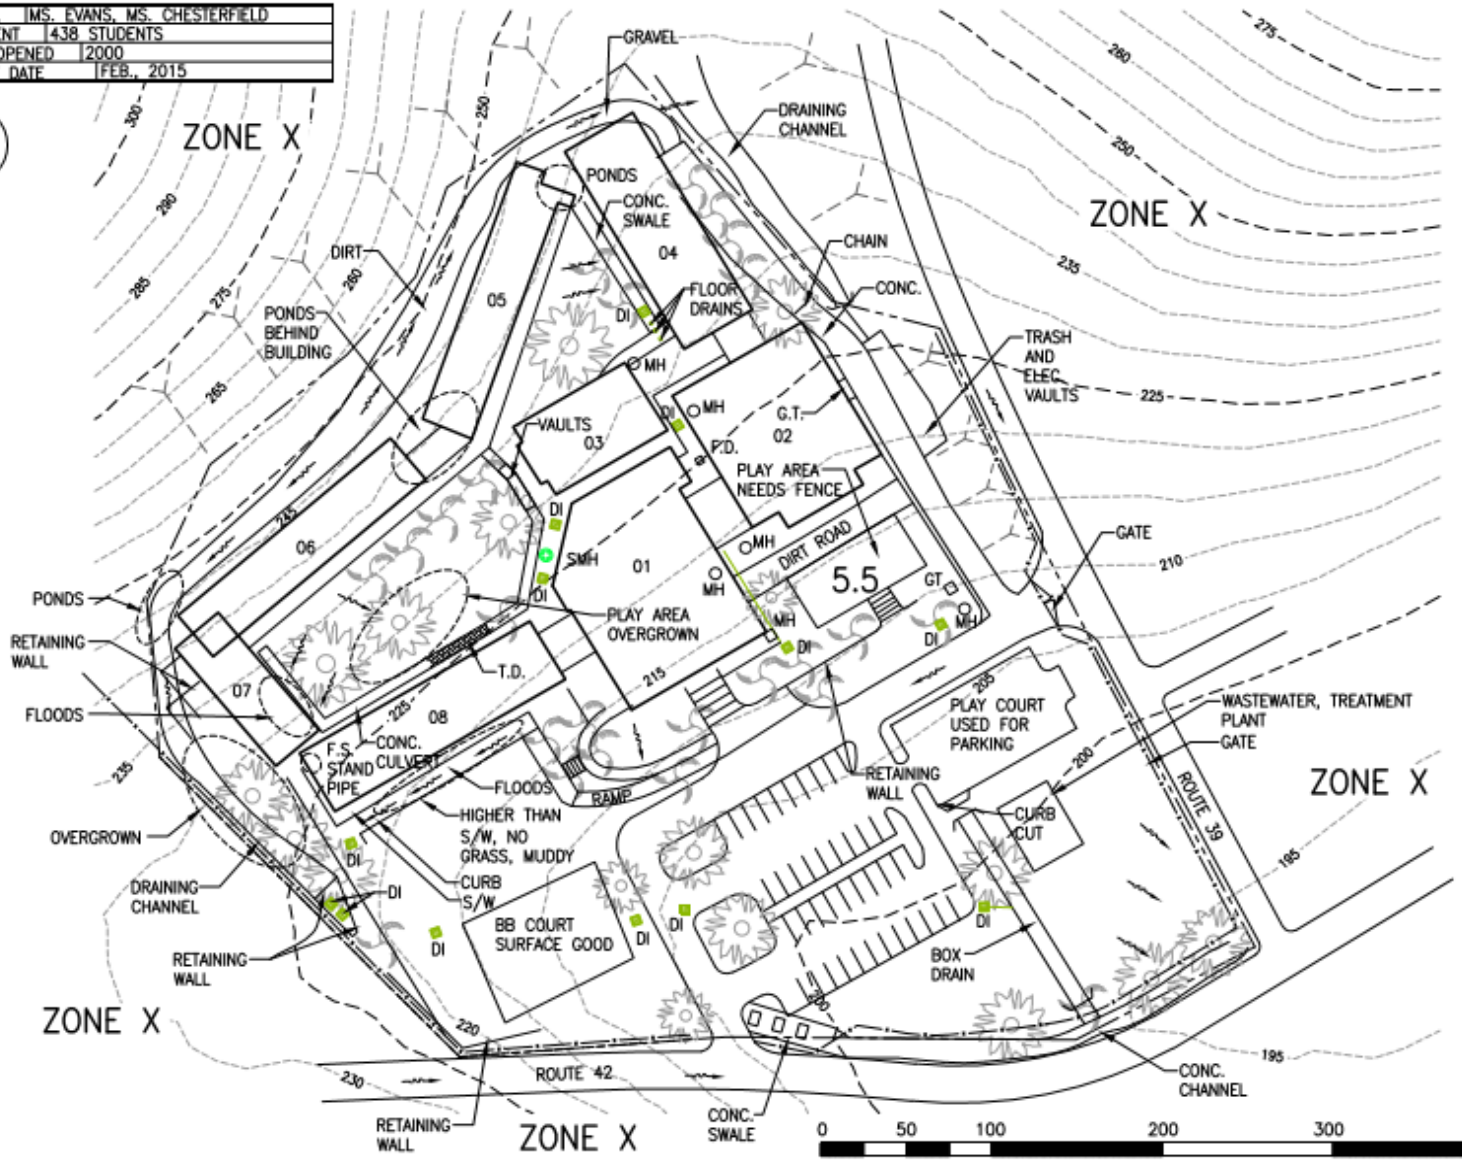
- SOME AREAS OF PONDING.
- ISSUES W/ GREASE TRAP, BACKS UP INSIDE OF KITCHEN.
- POSSIBLE SEWER LINE PROBLEM W/ TREE ROOTS.
- WATER IS TRUCKED IN EVERY TWO DAYS TO CISTERNS 1 AND 2.
- PUMP FOR WATER, WATER IS TEST TOO.
- NO FIRE HYDRANTS.
- ENOUGH PARKING FOR TEACHERS AND VISITORS .
- MOST OF STUDENTS BUSED, NO ISSUE W/ PICKUP AND DROP OFF
- HALF OF SCHOOL HAS FENCES
- FENCING AND GATES NEEDED
- RUBBER MATTING NEEDED FOR PLAYGROUND.
- NO ISSUES W/ RAMPS OR SIDEWALK.
- ONLY ONE AREA TO EVACUATE TO.
