MECHANICAL, ELECTRICAL, PLUMBING, AND FIRE PROTECTION  
SUMMARY REPORT  
UNITED STATES VIRGIN ISLANDS  
October 2015

Prepared by:  
InSynergy Engineering, Inc.

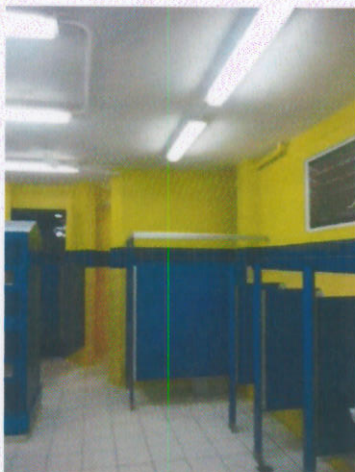
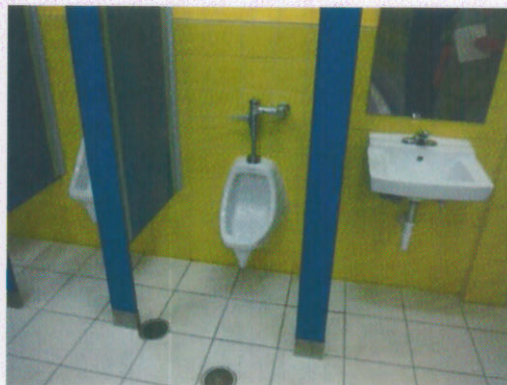
##### 1. Building 14

Locker / restrooms were renovated. All plumbing fixtures, ventilation and lighting systems were satisfactory.

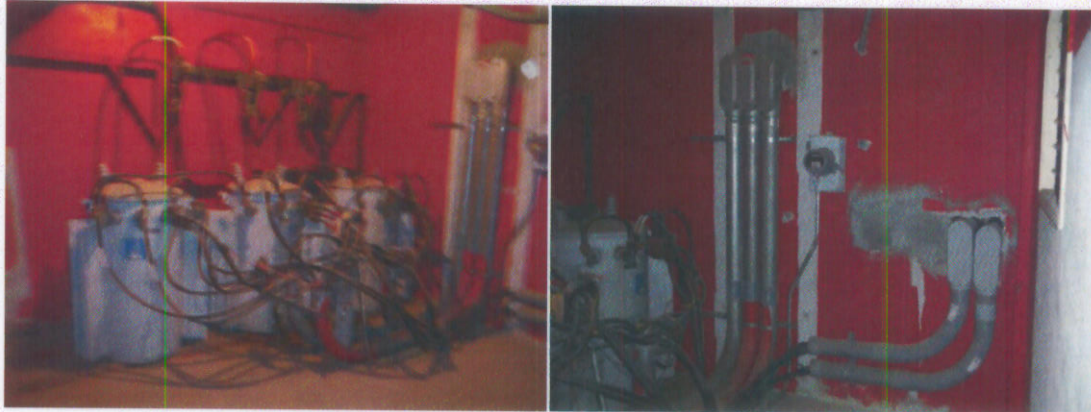
#### 4. Electrical System

Transformers are inside a room at the lower level of the cafeteria building. An enclosed corridor has been added to the front of the transformer room. The electrical room is adjacent to the transformer room with unsealed openings.

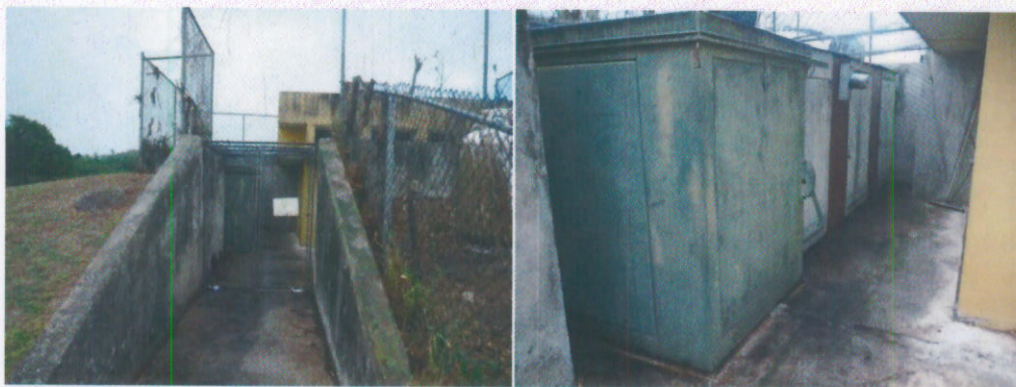
4. Electrical system

WAPA transformer installed in poor location and should be relocated for better access and safety.

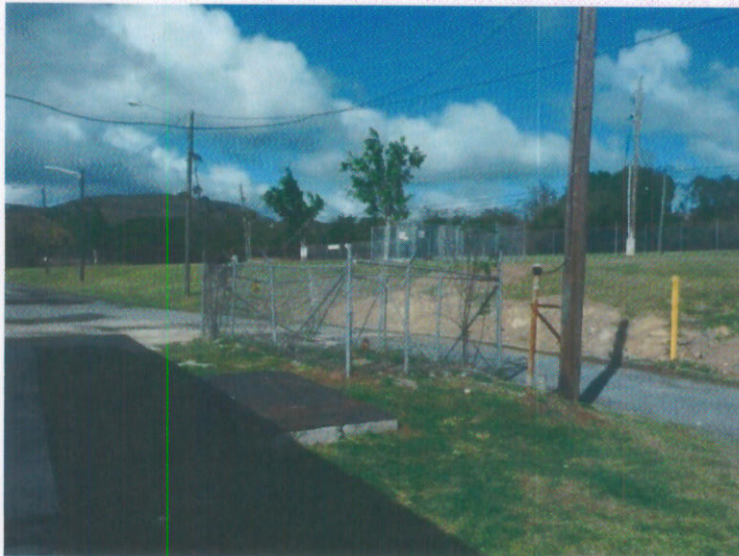
### 2. Electrical system

New WAPA pad mounted transformer installed above roadway and old transformer removed within fenced area.

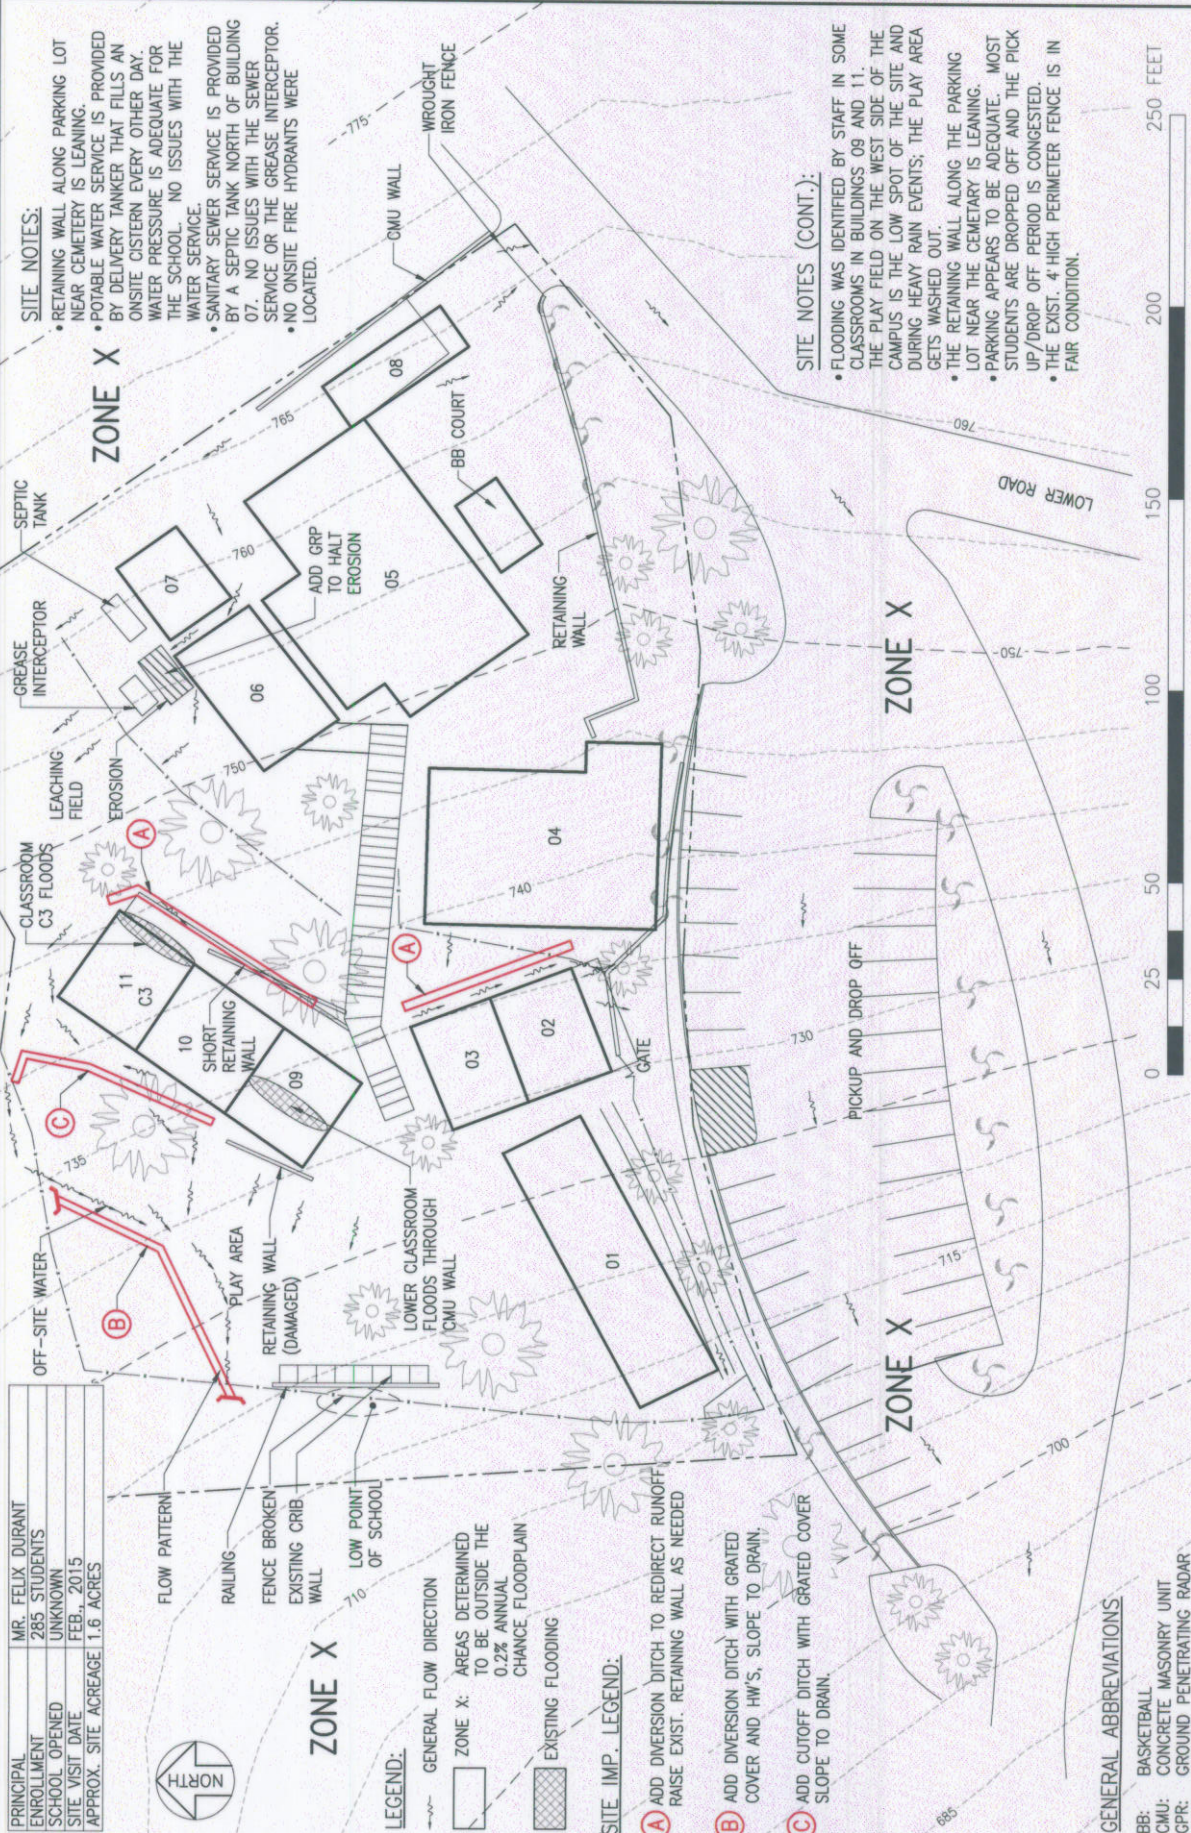
JOSEPH SIBILLY ELEMENTARY SCHOOL

- RETAINING WALL ALONG PARKING LOT NEAR CEMETERY IS LEANING.
- POTABLE WATER SERVICE IS PROVIDED BY DELIVERY TANKER THAT FILLS AN ONSITE CISTERN EVERY OTHER DAY.
- WATER PRESSURE IS ADEQUATE FOR THE SCHOOL. NO ISSUES WITH THE WATER SERVICE.
- SANITARY SEWER SERVICE IS PROVIDED BY A SEPTIC TANK NORTH OF BUILDING 07. NO ISSUES WITH THE SEWER SERVICE OR THE GREASE INTERCEPTOR.
- NO ONSITE FIRE HYDRANTS WERE LOCATED.
