Preliminary Disaster Damage Assessment

Government House, St. Croix, Frederiksted

315 Prince Street, Frederiksted, St. Croix, 00840

US VIRGIN ISLANDS PRELIMINARY DISASTER DAMAGE ASSESSMENT REPORT
AND COST ESTIMATE FOR HISTORIC STRUCTURES

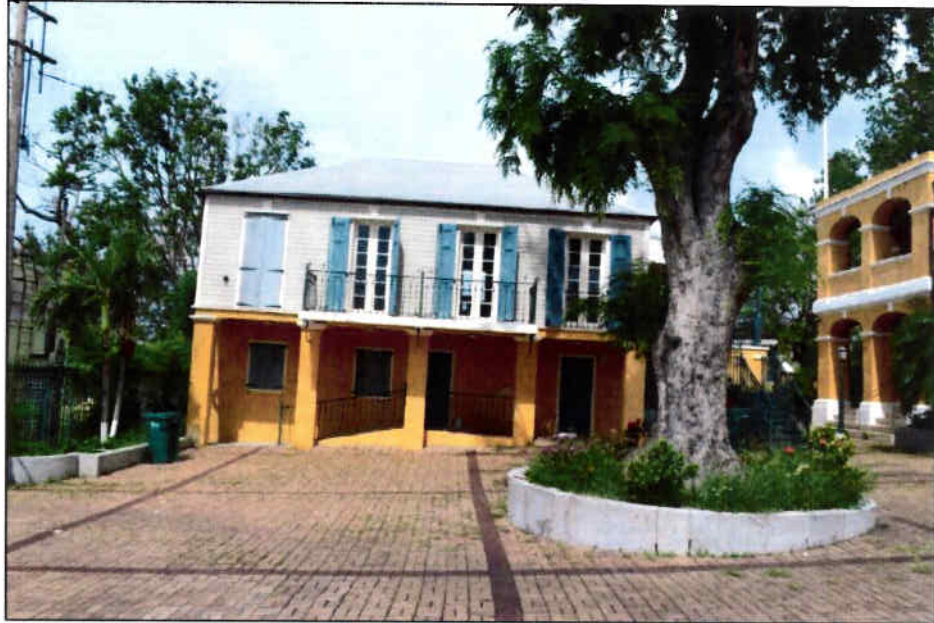
Figure 3: Danish School Kitchen Building, South Elevation, Looking North. Taken 11/7/2017

- Although non-historic, care should be taken to protect all interior surfaces during restoration work (repairing plaster, wood plank ceilings, Figures 3 and 4), to the extent possible.

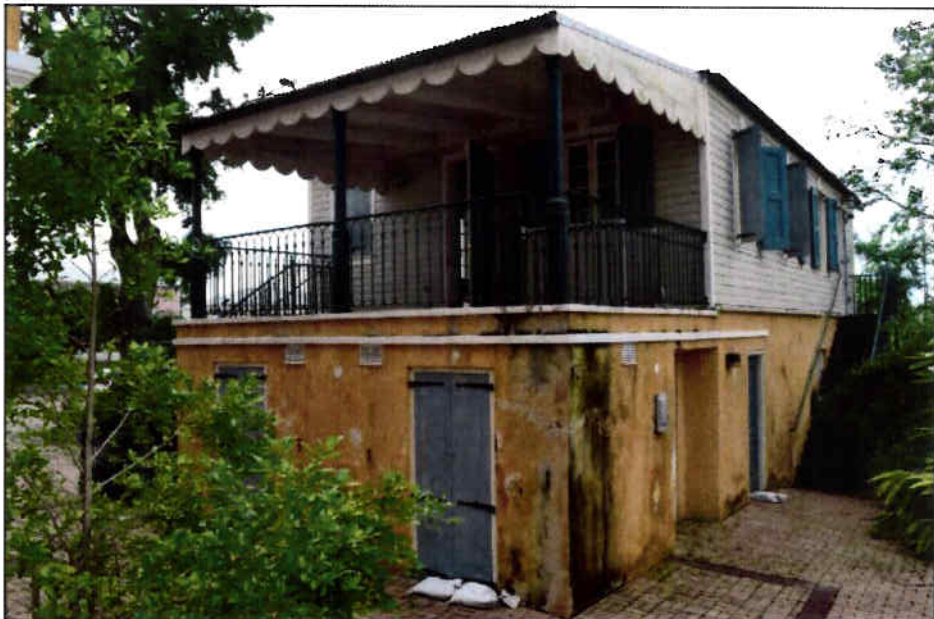
Figure 4: Danish School Kitchen Building, East and North Elevations, Looking Southwest. Taken 11/7/2017.
