THE VIRGIN ISLANDS DEPARTMENT OF  
**EDUCATION**

**REQUEST FOR PROPOSALS (RFP)  
FOR  
REPAIRS TO FIVE EDUCATIONAL CAMPUSES in the St. Croix School  
District**

The purpose of this Request for Proposals (RFP) is to solicit proposals from contractors qualified and experienced in the repair of educational facilities, the general scope of which is cosmetic in nature (i.e., limited structural, site, and MEP work).

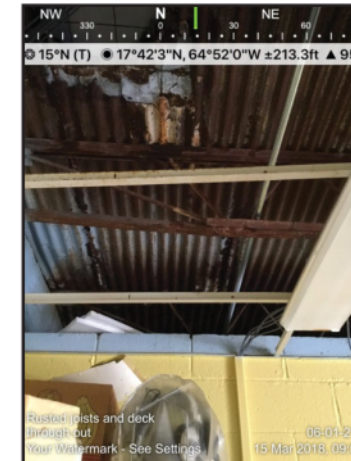
## Structural

Rusted Steel Decking

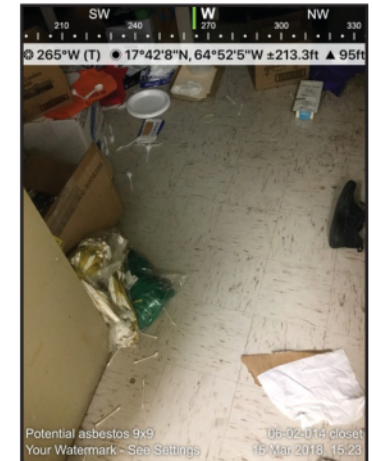
## Potential Asbestos

9"x9" Asbestos Tile

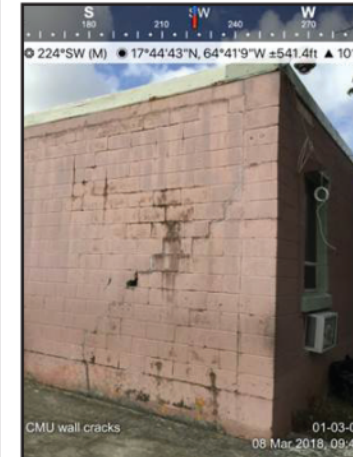
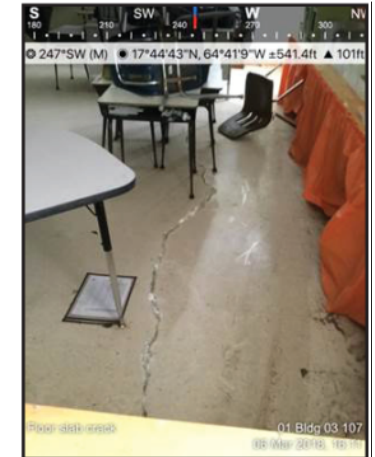
The Northeast wing classrooms, building 03, exhibit signs of structural settlement cracks in floors slabs and exterior CMU walls. Additional Structural evaluations will be required.
