PRINCIPAL MS. AUDVEY BOWRY  
 ENROLLMENT  
 SCHOOL OPENED 2000  
 SITE VISIT DATE FEB. 2015

OIA - ASSESSMENT OF BUILDINGS  
 AND CLASSROOMS  
 US VIRGIN ISLANDS - ST. THOMAS

**LOCKHART ELEMENTARY SCHOOL**

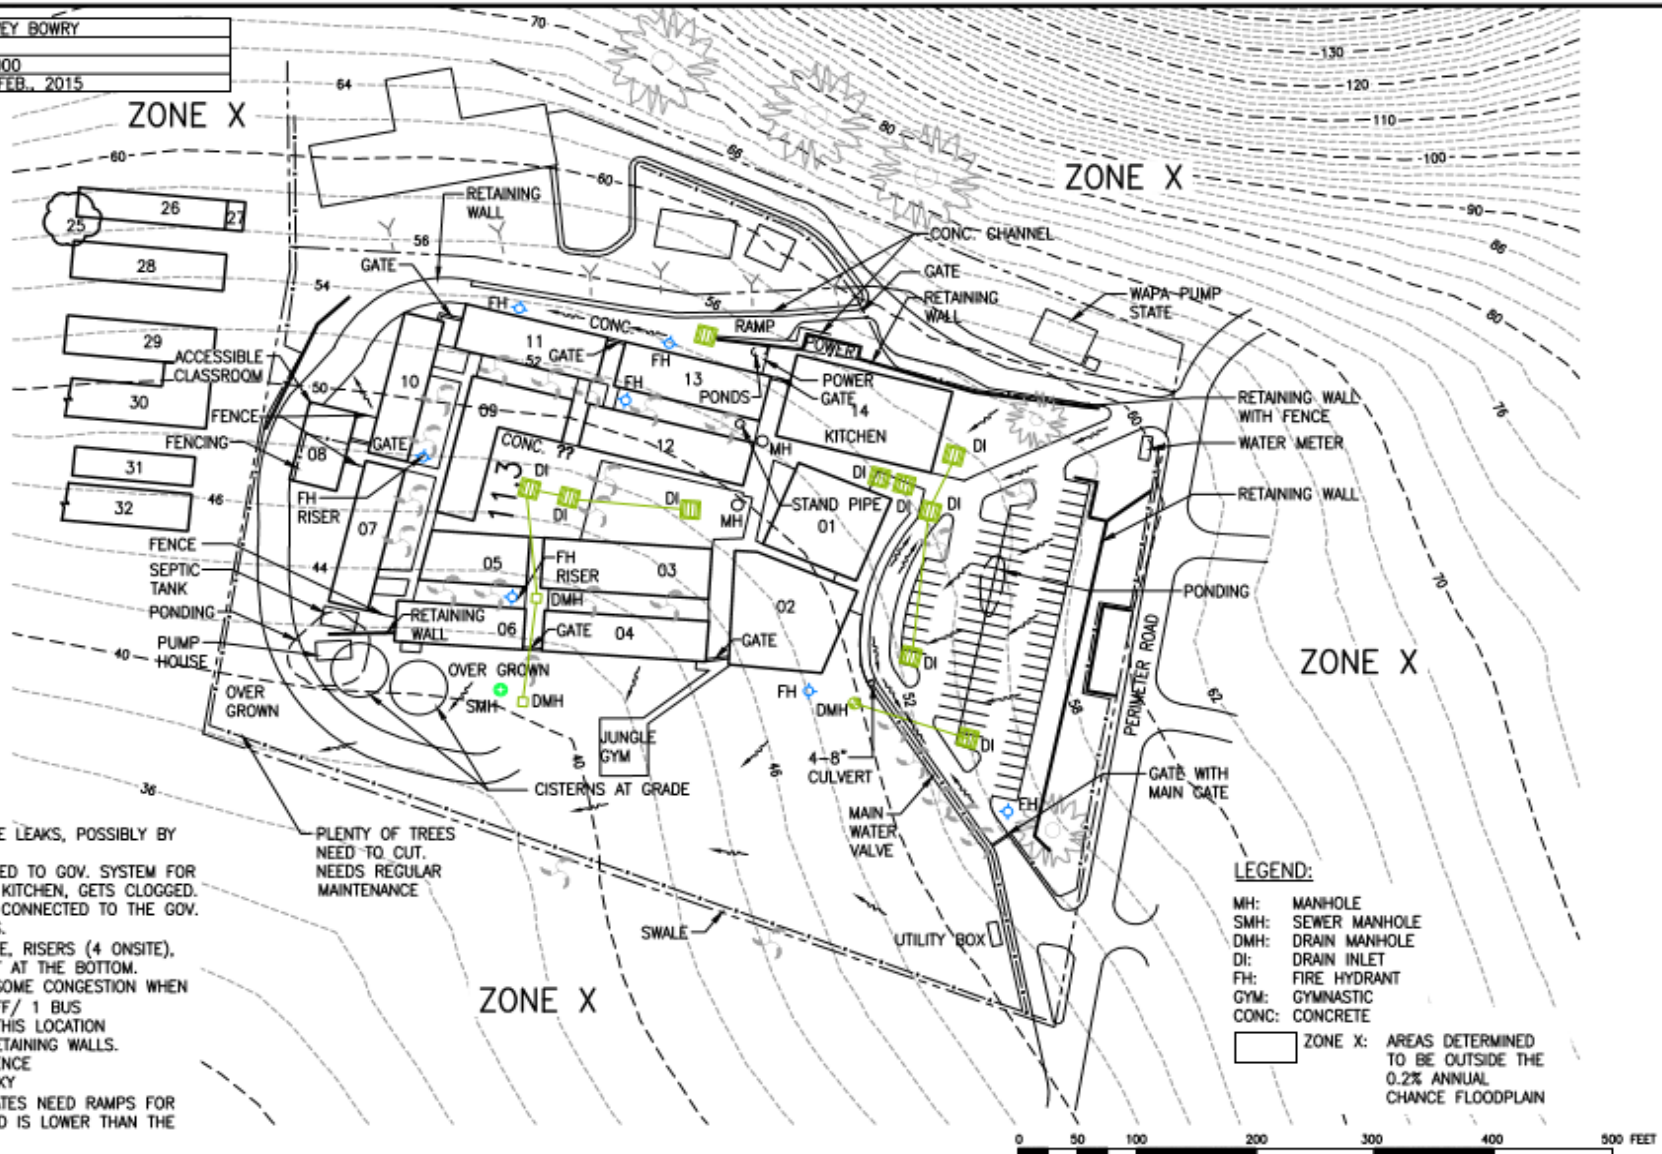
**13**

- NO FLOODING, SOME LEAKS, POSSIBLY BY OLD CISTERNS
- SEWER IS CONNECTED TO GOV. SYSTEM FOR SEWER, G.I. INSIDE KITCHEN, GETS CLOGGED.
- POTABLE WATER IS CONNECTED TO THE GOV. SYSTEM, NO ISSUES.
- FHs/ RISERS ONSITE, RISERS (4 ONSITE), BEGINNING TO RUST AT THE BOTTOM.
- MOST KIDS WALK, SOME CONGESTION WHEN PICK UP/ DROP OFF/ 1 BUS
- ESL - BUSED TO THIS LOCATION
- NO ISSUES WITH RETAINING WALLS.
- NO ISSUES WITH FENCE
- PLAY FIELD IS ROCKY
- S/W OKAY, EXIT GATES NEED RAMPS FOR WHERE THE GROUND IS LOWER THAN THE SIDEWALK

PLENTY OF TREES  
 NEED TO CUT.  
 NEEDS REGULAR  
 MAINTENANCE
